PACP Inspection Report

Upstream MH NN021574	Downstream MH NN021573	Size 12	Material Vitrified Clay Pipe	Total Length 0	City MEMPHIS, TN
Surveyor's Name S.TARRANT	Certificate Number 06-19342	Street Address 2150 CUSTER ST		Location Details STREET	
Direction Downstream	Purpose Capital Improvement Program Assessment	Weather Dry	Date 20131213	Time 11:16	Length Surveyed 385.7

Upstream MH NN021575	Downstream MH NN021574	Size 8	Material Concrete Pipe (non-reinforced)	Total Length 0	City MEMPHIS, TN
Surveyor's Name S.TARRANT	Certificate Number 06-19342	Street Address 2174 FREEMONT RD		Location Details STREET	
Direction Upstream	Purpose Capital Improvement Program Assessment	Weather Dry	Date 20131213	Time 13:46	Length Surveyed 188.8
Additional Information CLEAN & CCTV, REVERSE SETUP

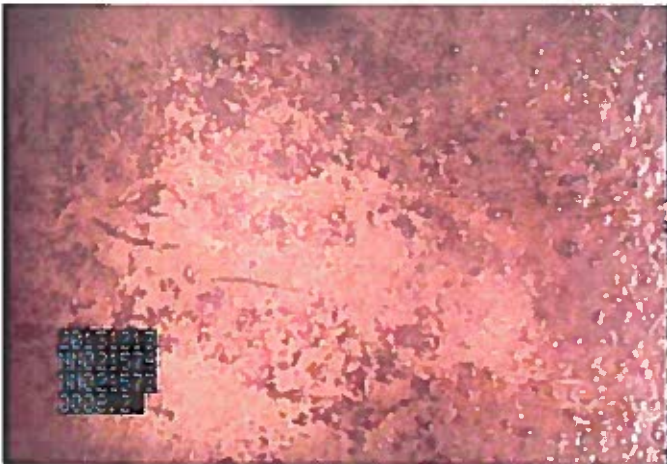
CL - Crack Longitudinal @ 8.2 ft.

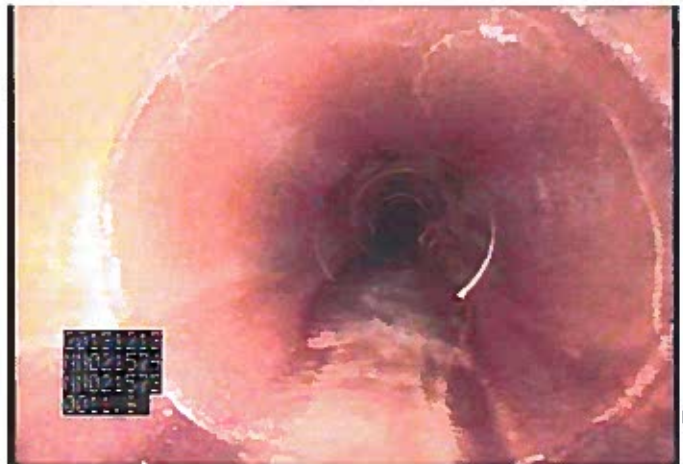
CM - Crack Multiple @ 11.8 ft.

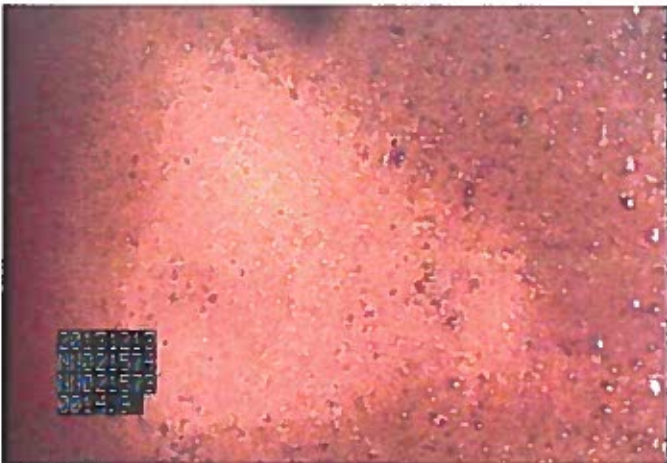
CL - Crack Longitudinal @ 14.9 ft.

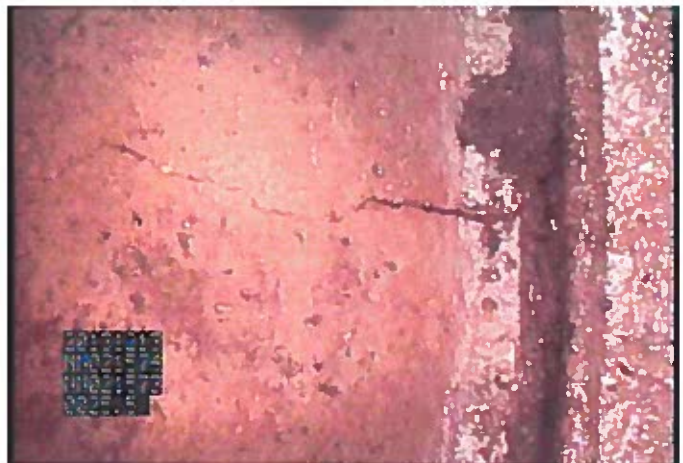
FL - Fracture Longitudinal @ 25.5 ft.

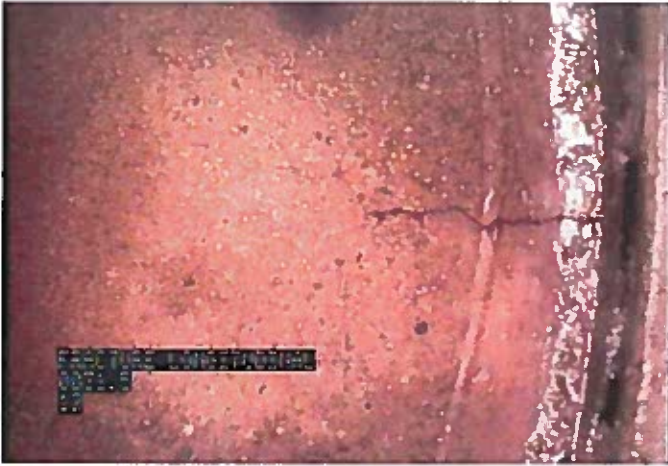
CL - Crack Longitudinal @ 31.5 ft.

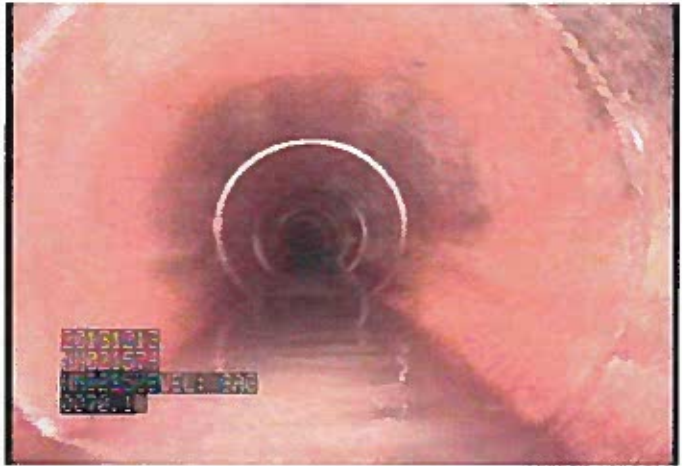
MWLS - Water Level: Sag @ 70.1 ft.

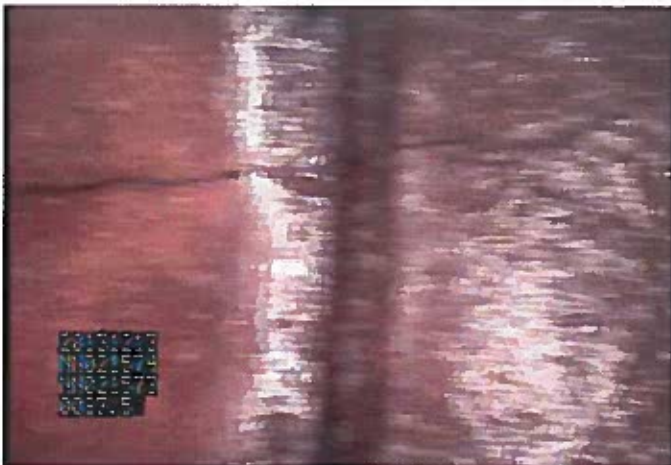
FL - Fracture Longitudinal @ 83.5 ft.

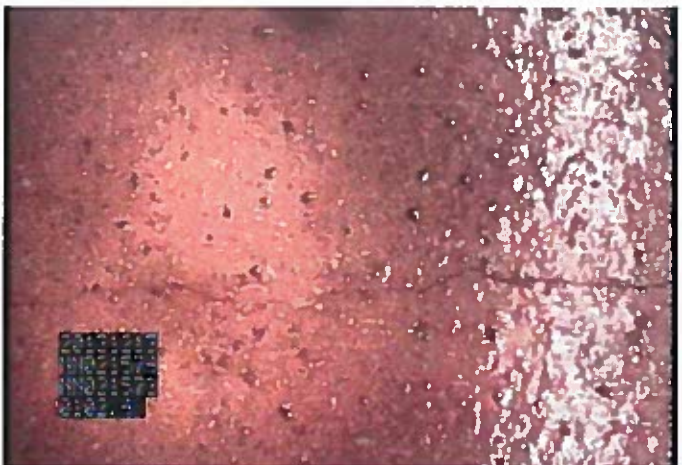
FL - Fracture Longitudinal @ 102.4 ft.

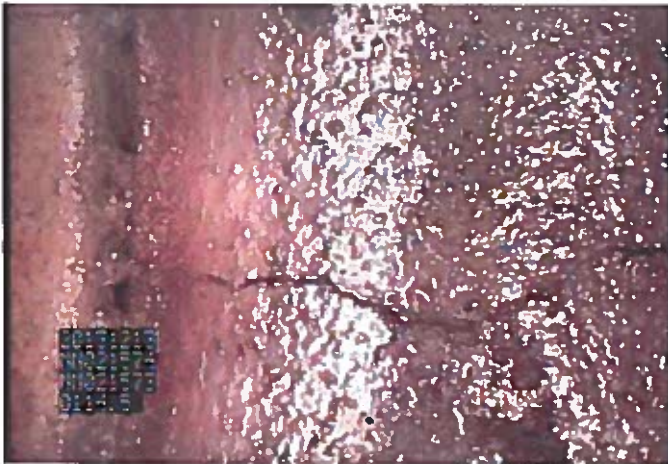
FL - Fracture Longitudinal @ 114.5 ft.

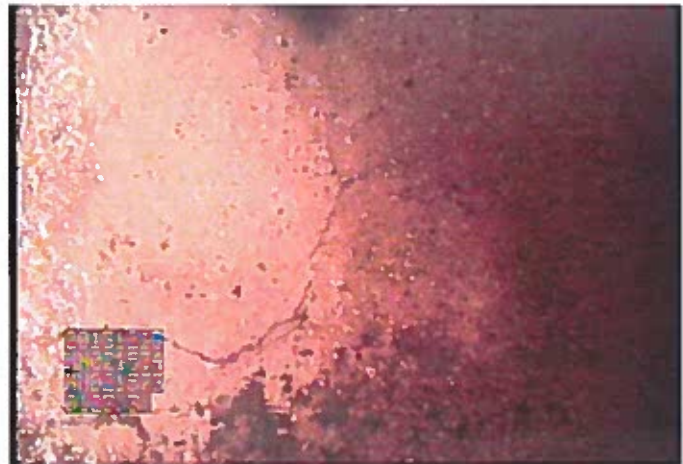
CM - Crack Multiple @ 123.3 ft.

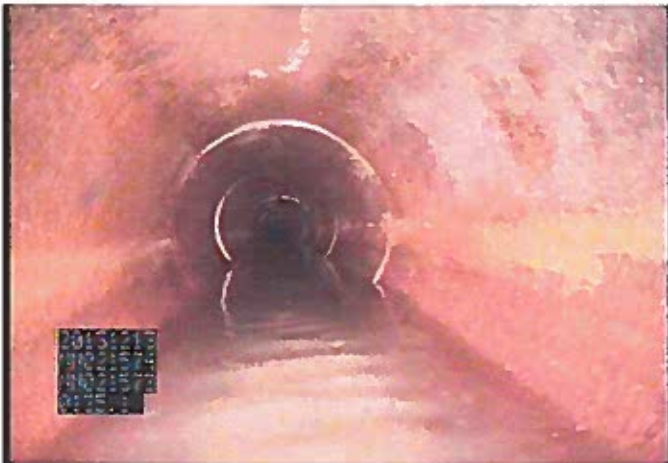
DAGS - Deposits Attached: Grease @
135.1 ft.

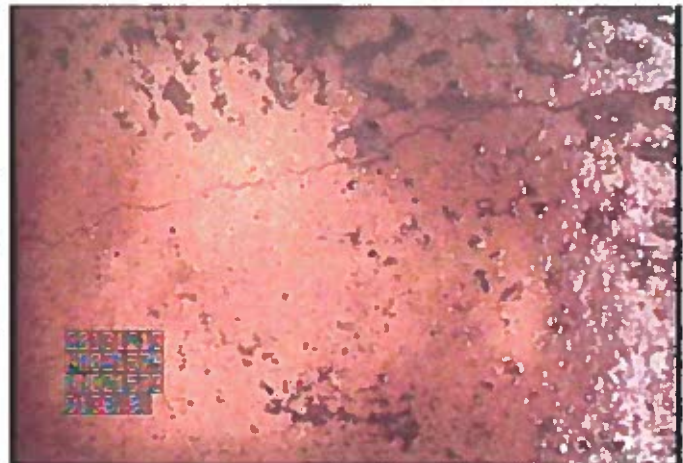
CL - Crack Longitudinal @ 138.7 ft.

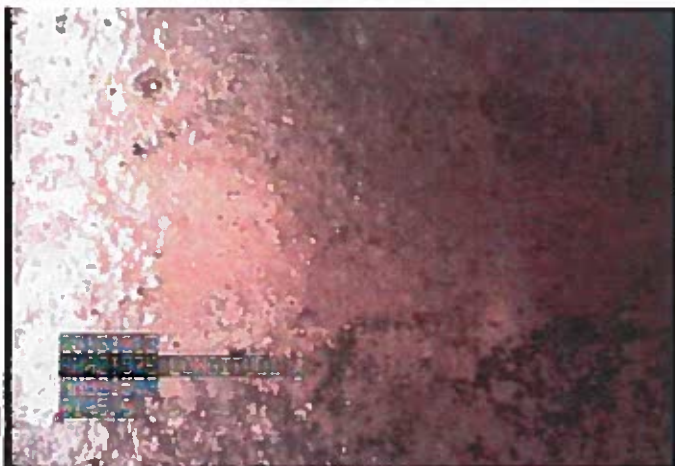
FL - Fracture Longitudinal @ 145.0 ft.

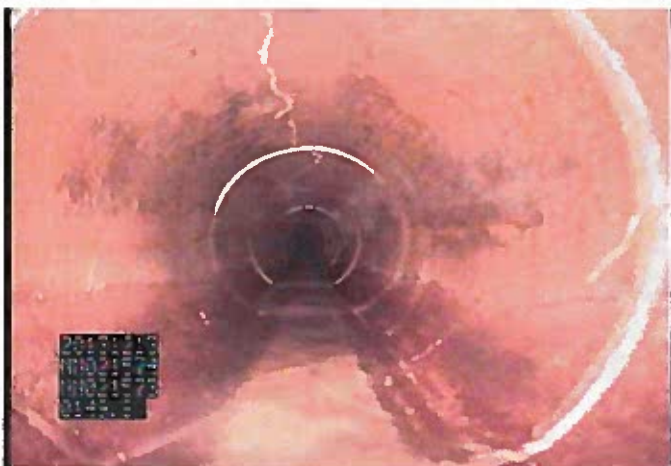
CM - Crack Multiple @ 149.8 ft.

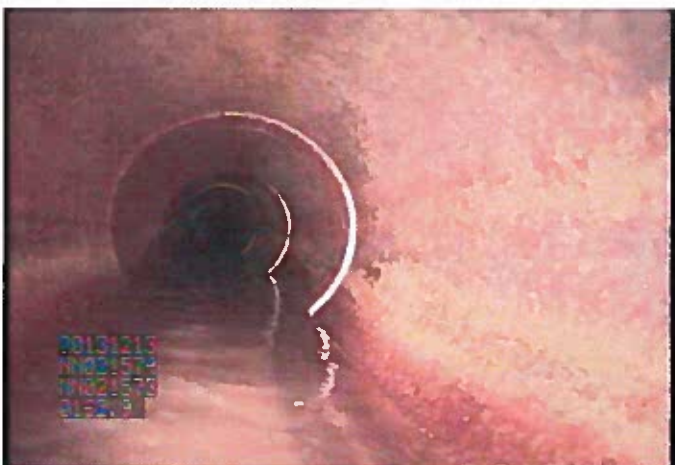
FL - Fracture Longitudinal @ 161.2 ft.

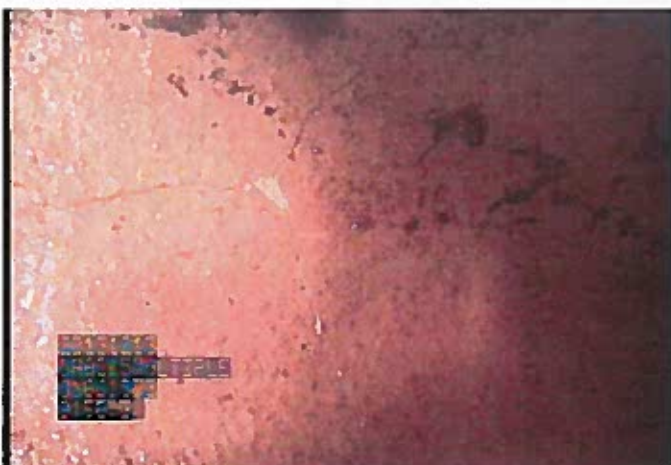
CM - Crack Multiple @ 166.3 ft.

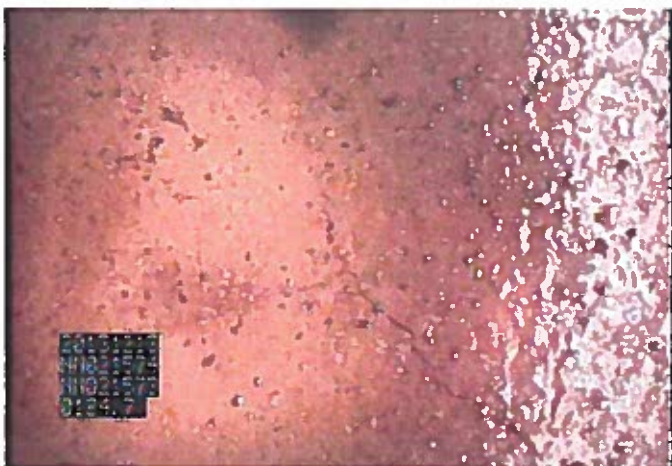
CS - Crack Spiral @ 184.7 ft.

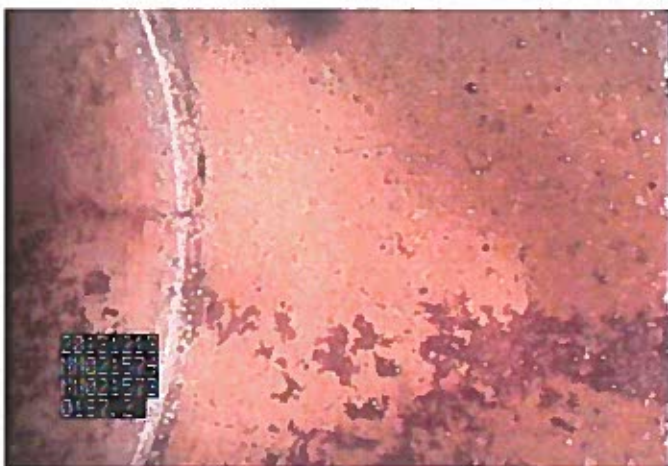
CL - Crack Longitudinal @ 187.2 ft.

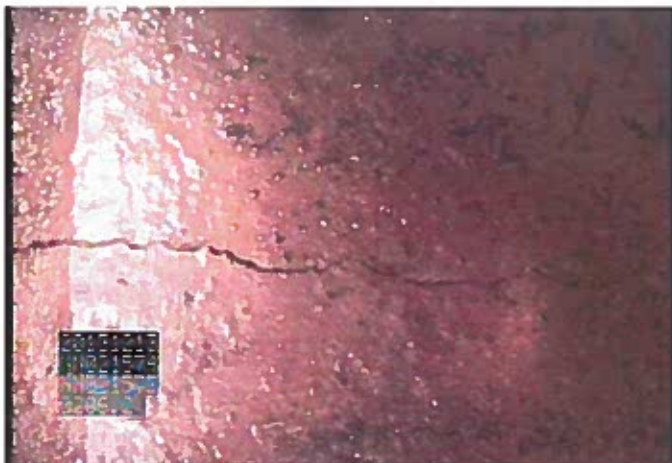
FL - Fracture Longitudinal @ 206.2 ft.

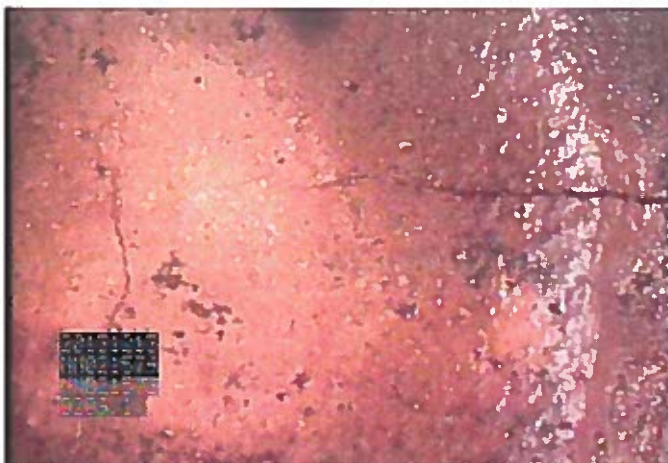
FM - Fracture Multiple @ 209.1 ft.

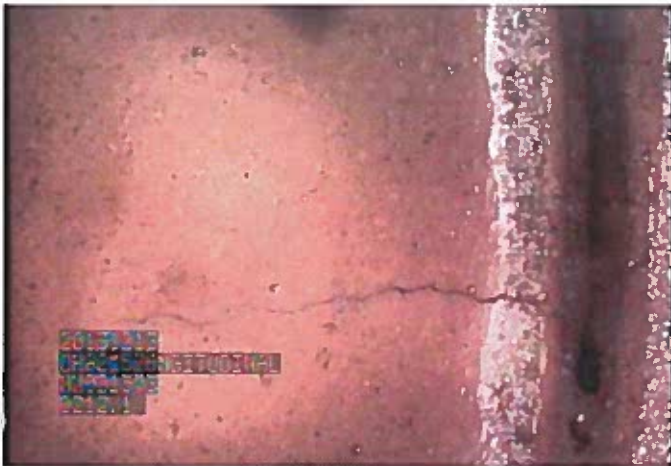
CL - Crack Longitudinal @ 212.1 ft.

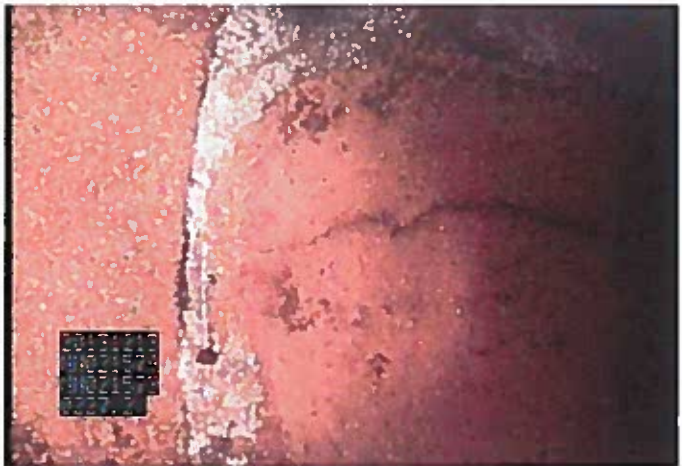
CL - Crack Longitudinal @ 227.2 ft.

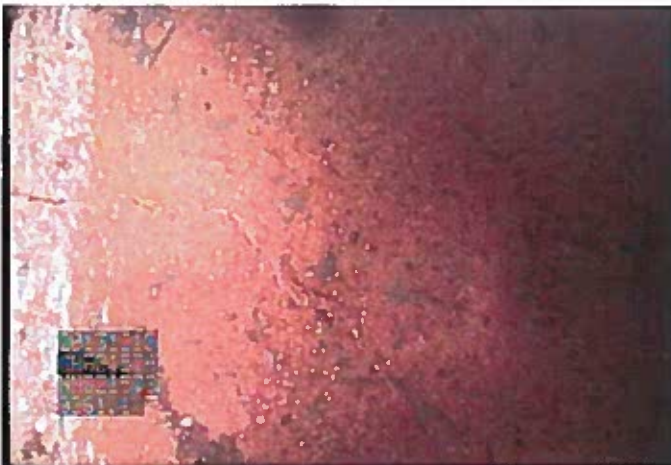
CM - Crack Multiple @ 261.1 ft.

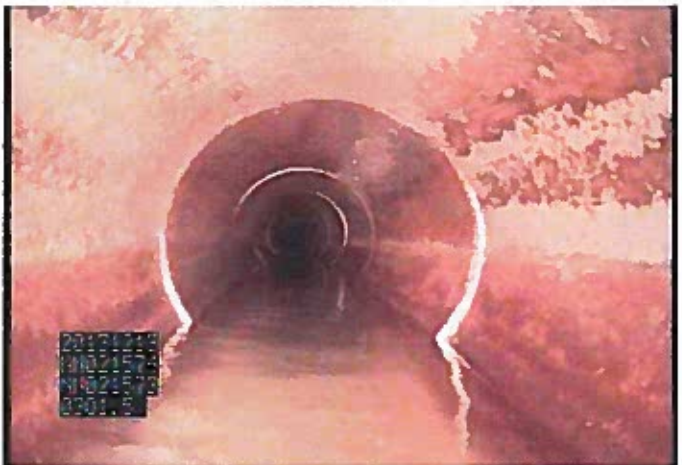
MWLS - Water Level: Sag @ 301.5 ft.

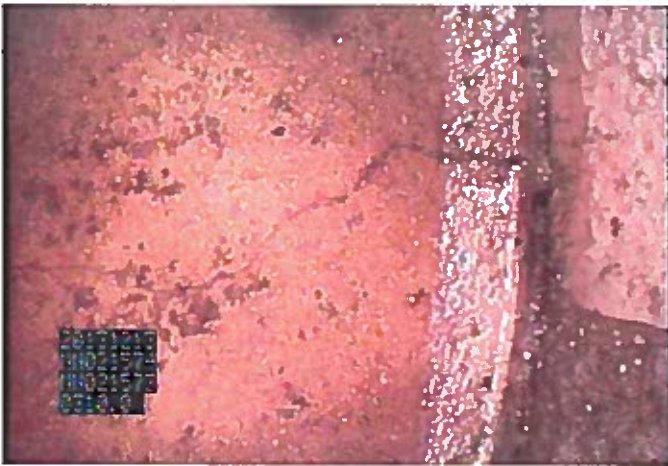
CL - Crack Longitudinal @ 310.0 ft.

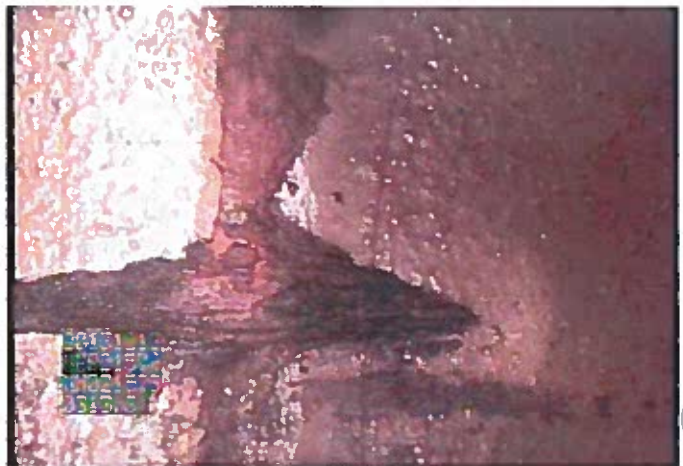
DAZ - Deposits Attached: Other @ 313.3 ft. ENCRUSTATION ATTACHED

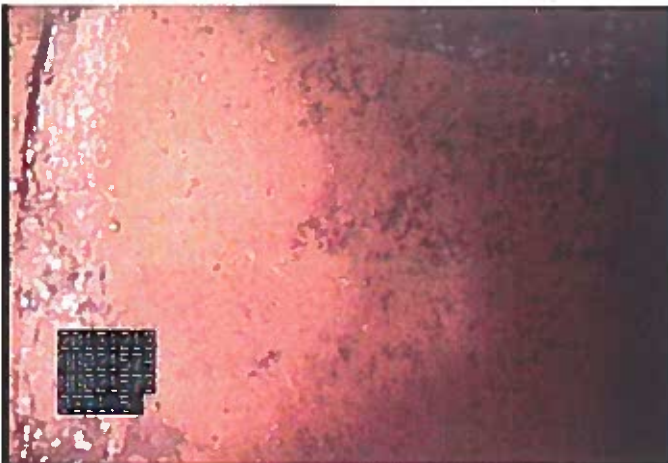
CL - Crack Longitudinal @ 331.5 ft.

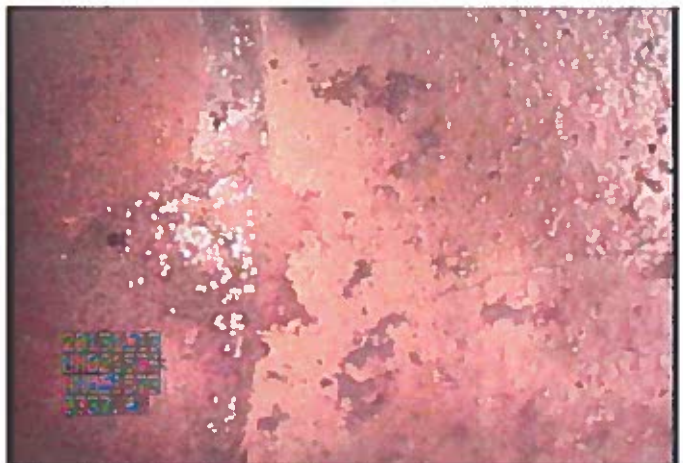
CL - Crack Longitudinal @ 337.4 ft.

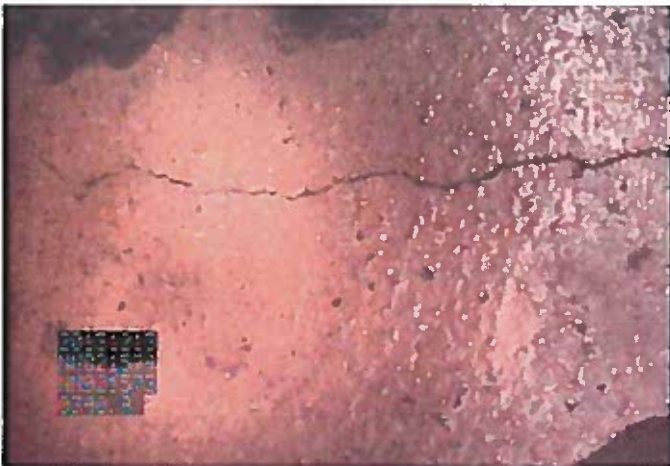
FL - Fracture Longitudinal @ 340.9 ft.

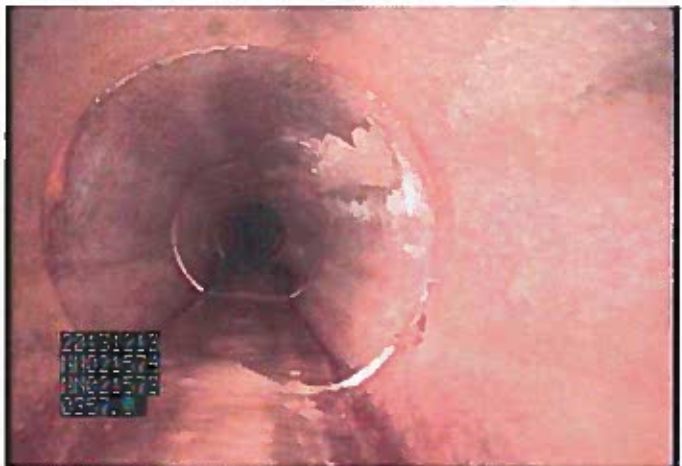
FL - Fracture Longitudinal @ 351.6 ft.

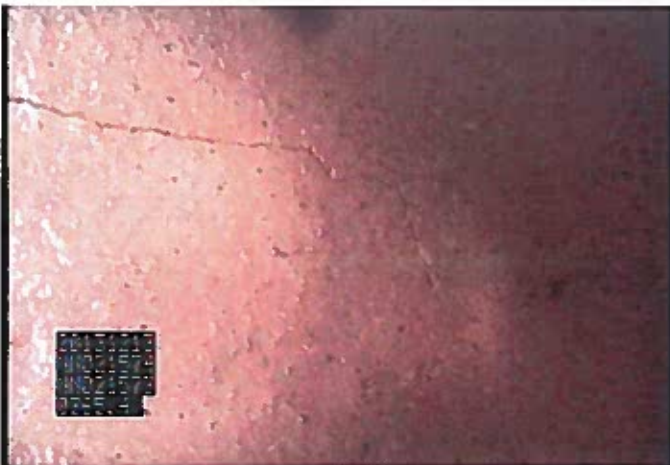
FM - Fracture Multiple @ 365.4 ft.

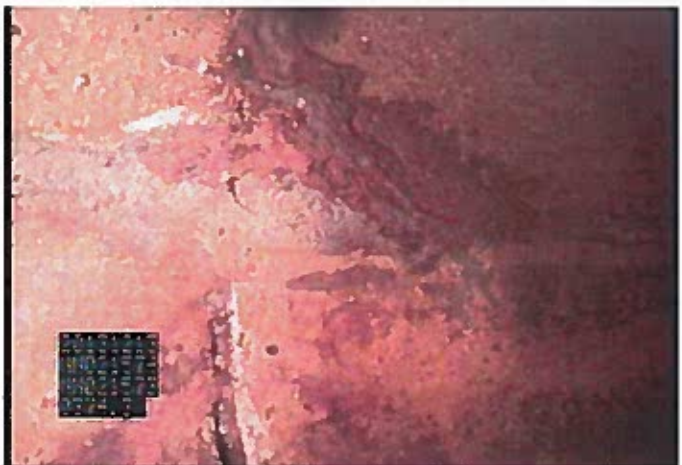
DAE - Deposits Attached: Encrustation @ 374.3 ft.

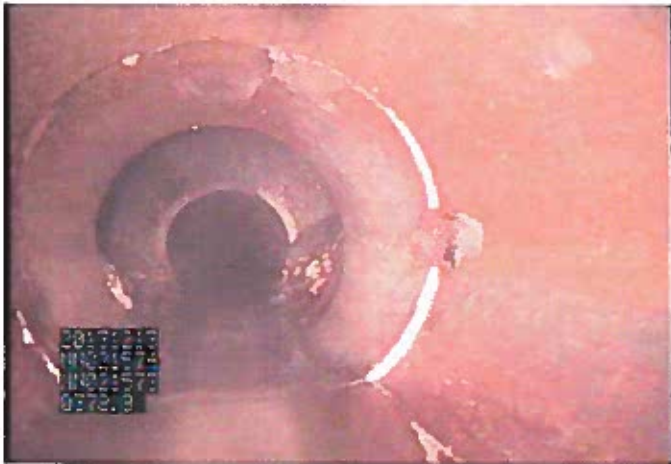
DAGS - Deposits Attached: Grease @
378.8 ft.

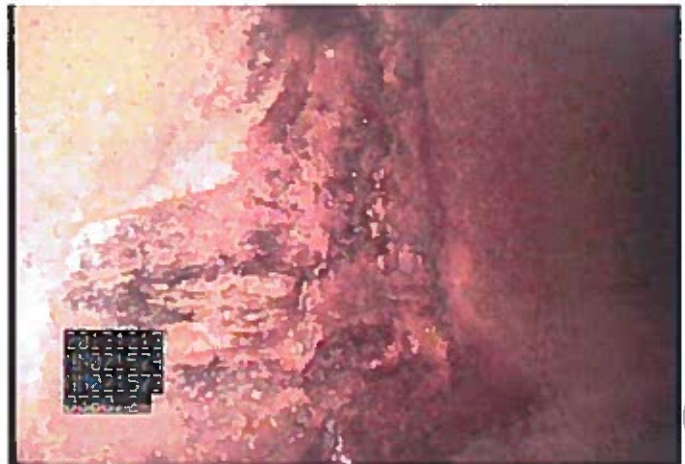
DAE - Deposits Attached: Encrustation @
380.2 ft.

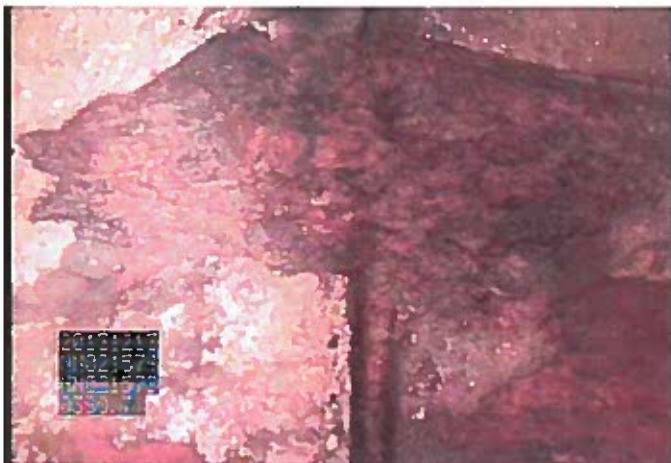
DAE - Deposits Attached: Encrustation @
380.7 ft.

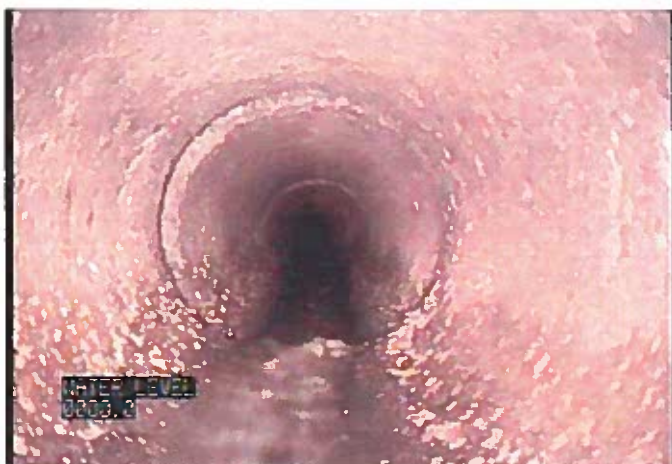
SAP - Surface: Aggregate Projecting @ 0.0 ft.

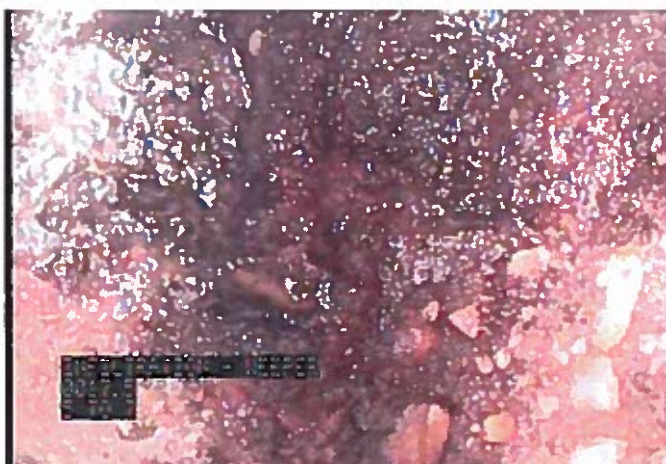
IW - Infiltration - Weeper @ 17.5 ft.

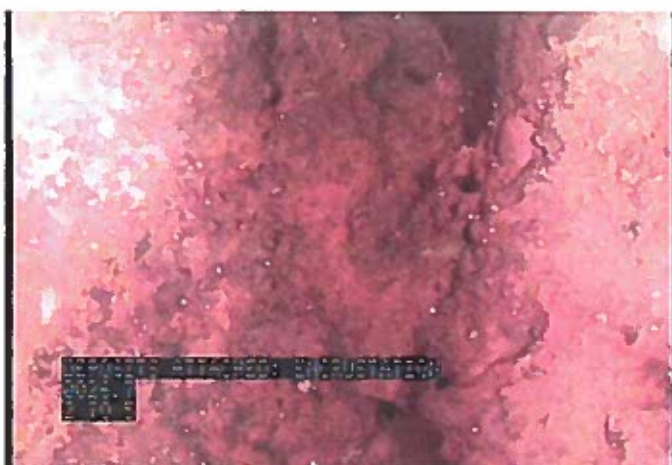
DAE - Deposits Attached: Encrustation @ 26.7 ft.

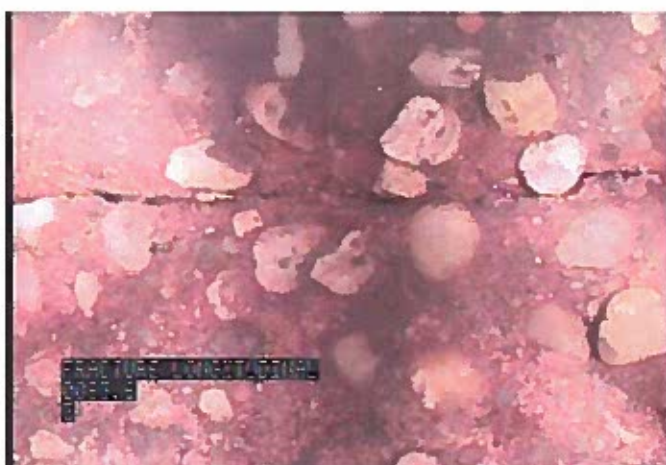
FL - Fracture Longitudinal @ 83.6 ft.

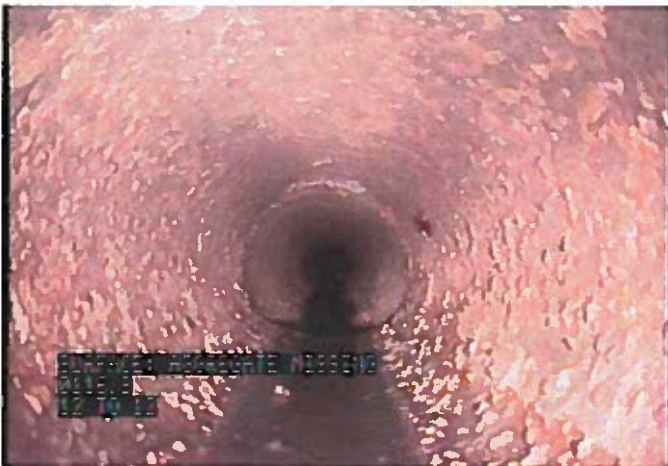
SAM - Surface: Aggregate Missing @ 116.8 ft.

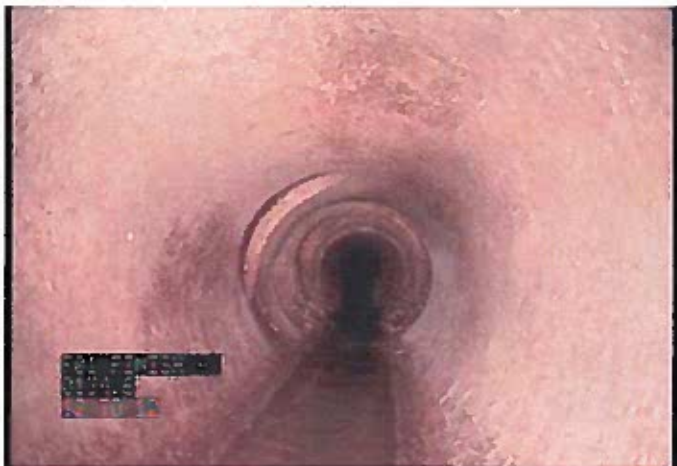
SAM - Surface: Aggregate Missing @ 134.6 ft.

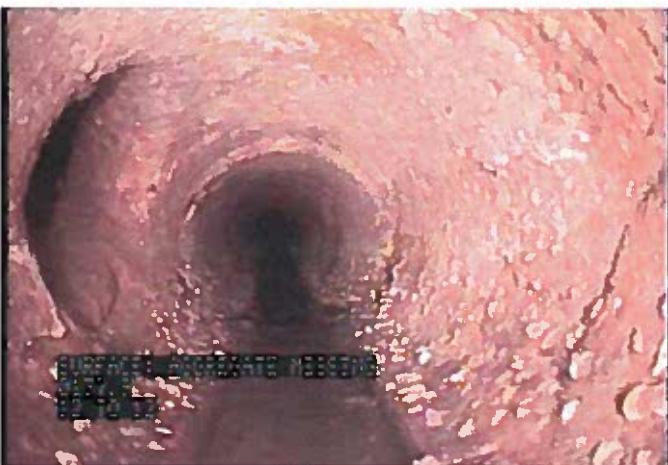
SAM - Surface: Aggregate Missing @ 137.9 ft.

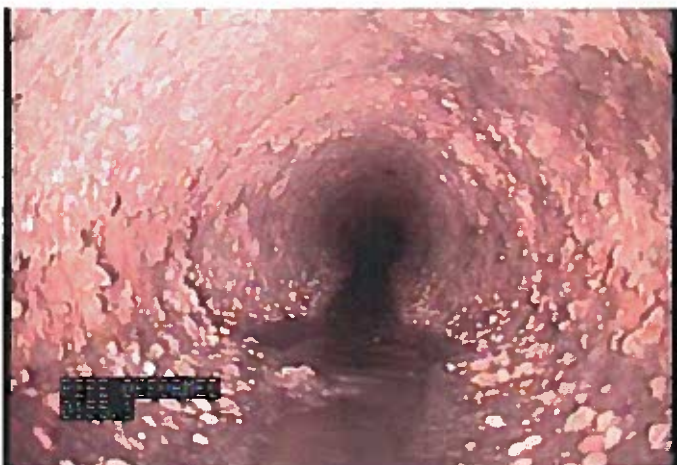
D - Pipe Deformed @ 155.1 ft.

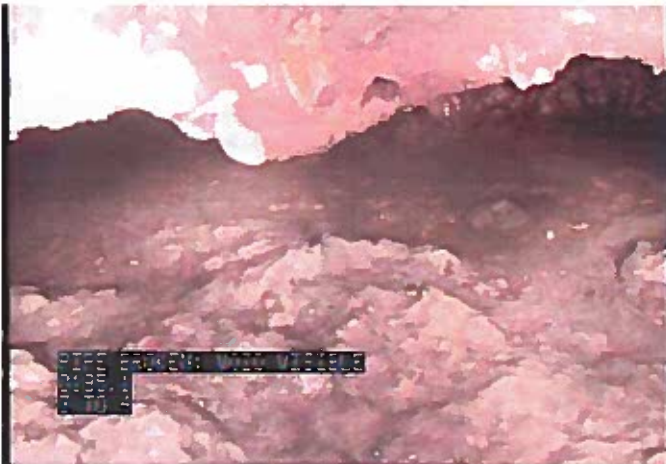
BVV - Pipe Broken: Void Visible @ 185.1 ft.

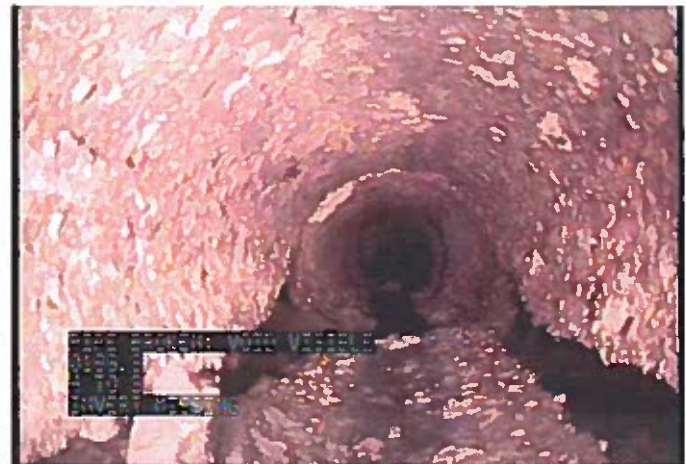
SAP - Surface: Aggregate Projecting @ 188.8 ft.

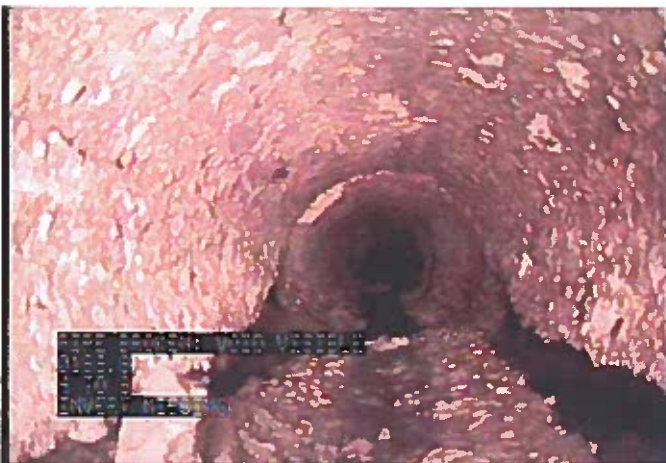
BVV - Pipe Broken: Void Visible @ 188.8 ft. INVERT MISSING

Reviewed By 1: Nolan Mills Date: 3/16/2014 Review Comments: Pipe is missing in some places
 Reviewed By 2: Date: Review Status: Approved
 Exceptions Noted: Report OK: Video OK:

PACP Scores	Rating	Quick	Index	PM Recommendations	Rehab Recommendations
Structural:				Criticality: Low	Criticality: High
O&M:				Recom / Frequency1: Jet 12 Months	Rehab Recom 1: Mainline Relay
Overall:				Recom / Frequency2:	Rehab Recom 2:

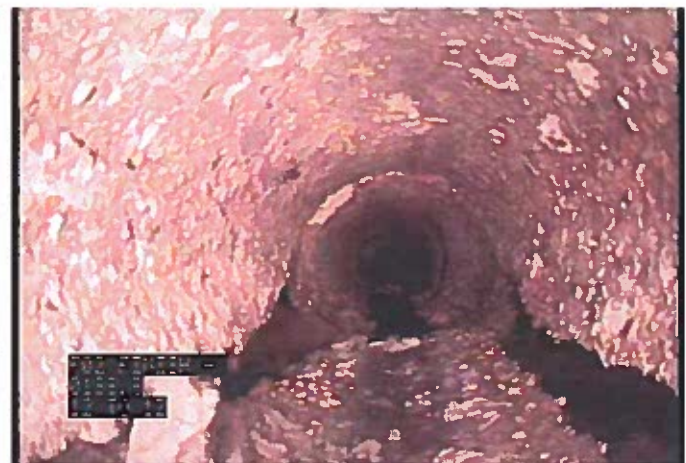
SAM - Surface: Aggregate Missing @ 188.8 ft.
