City of Memphis

Interim Priority Areas Project Report

October 11, 2018

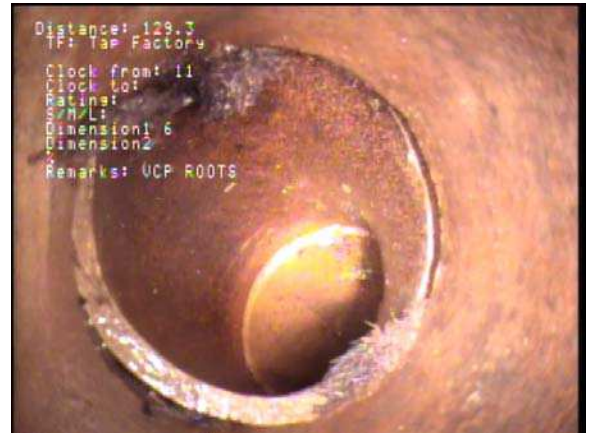
TF Tap Factory -- VCP -- ROOTS 129.3 l.f.

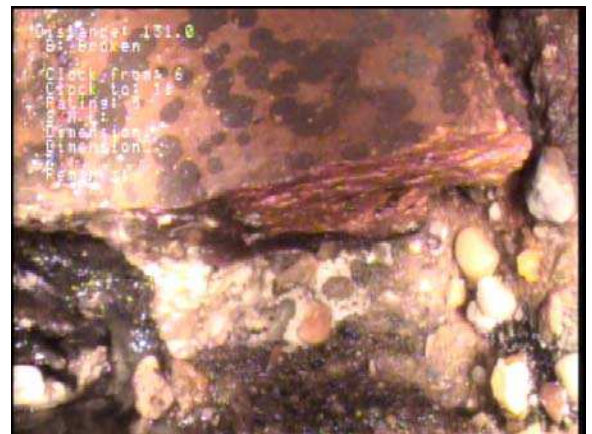
B Broken 131 l.f.

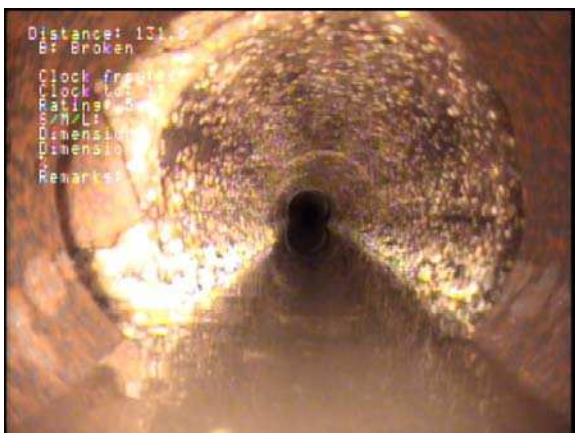
B Broken 131 l.f.

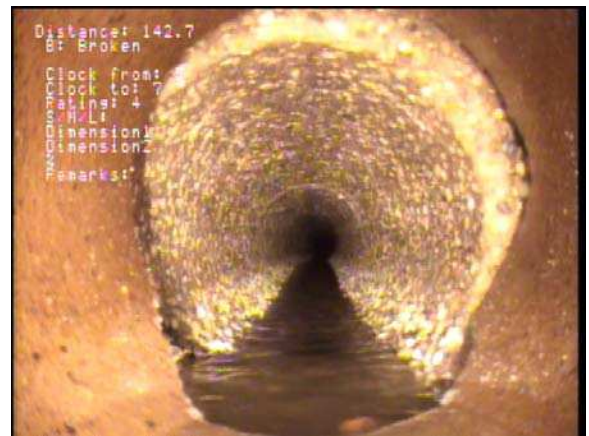
B Broken 142.7 f.f.

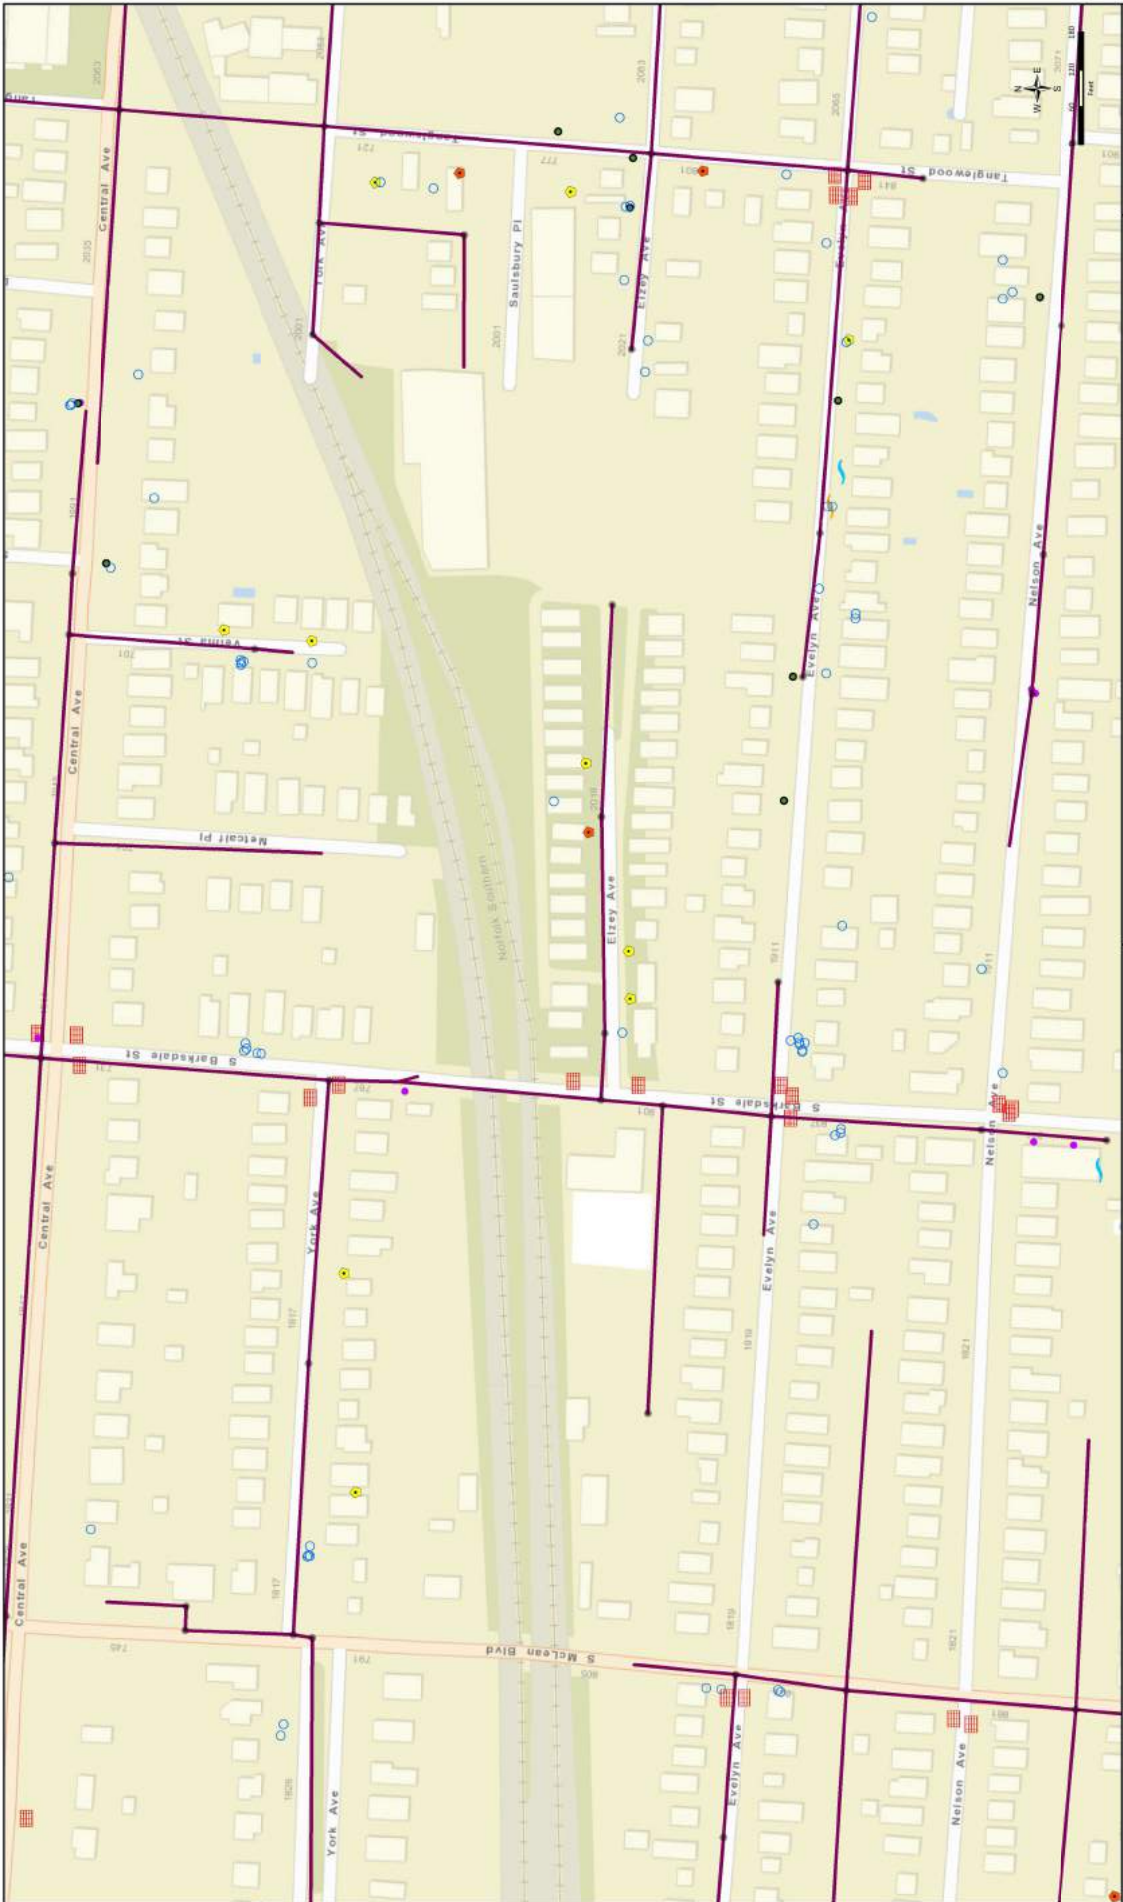
Smoke Testing Defect Map

Smoke Defects in Northern and Southern Priority Rehab Areas

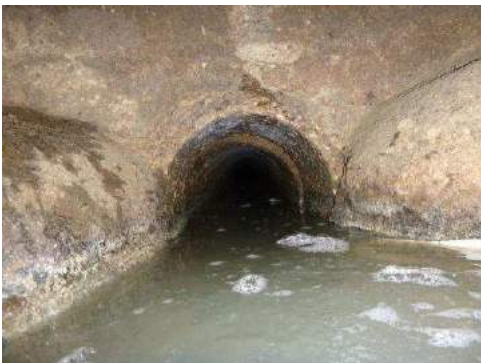
Pipe #:	1	Clock:	6	Rim to Invert:	10.1
Direction:	Out	Material:	Concrete Pipe (non-reinf)		
Shape:	Circular	Dia 1:	8	Dia 2	0
Pipe Condition:	Defective	Seal Condition:	Sound		
Special Condition:	Gravity Relief Connection		Pipe ID:	NN022450	
Comments:
