Manhole Inspection Header Form  
Level 1 & 2 Inspections

**Manhole Number** NN020517

**Purpose** Sewer System Evaluation Survey

**PO Number**  
**Date** 02/01/2014      **Time** 7:49 am  
**Street** LAPALOMA AND PARKWAY      **City** Memphis  
**Location** CENTER STREET  
**Manhole Number** NN020516      **Rim to Invert** 7.92      **Grade to Invert** 7.92      **Rim to Grade** 0.00

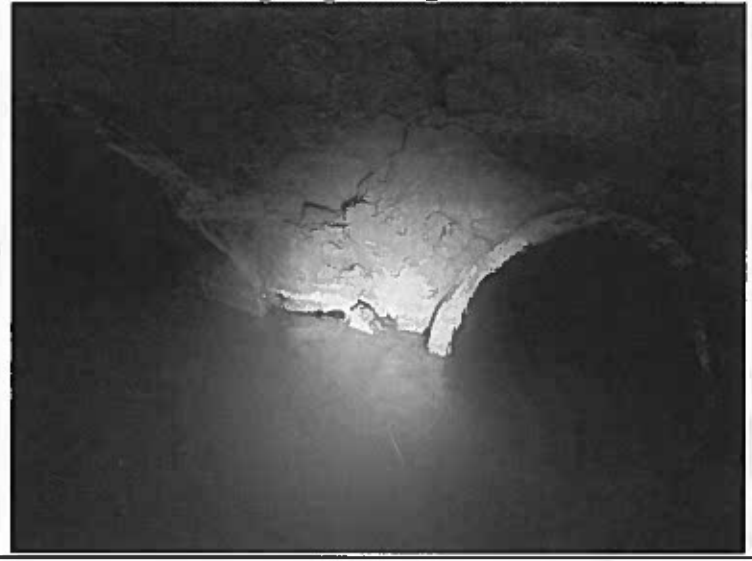
NN020516\_MACP\_20140201\_003.JPG

Depth	Counter	Component	Descript	Code		Value			Circumfrential Location			
				Modifier/ Severity	Contin Defect	S/M/L	1st	2nd	%	Joint	Step	Clock From
7.00		Channel	B						No	No	2

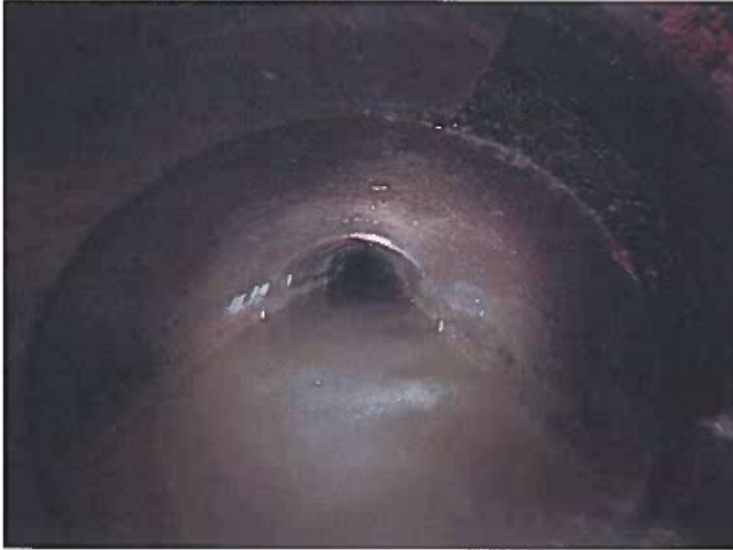
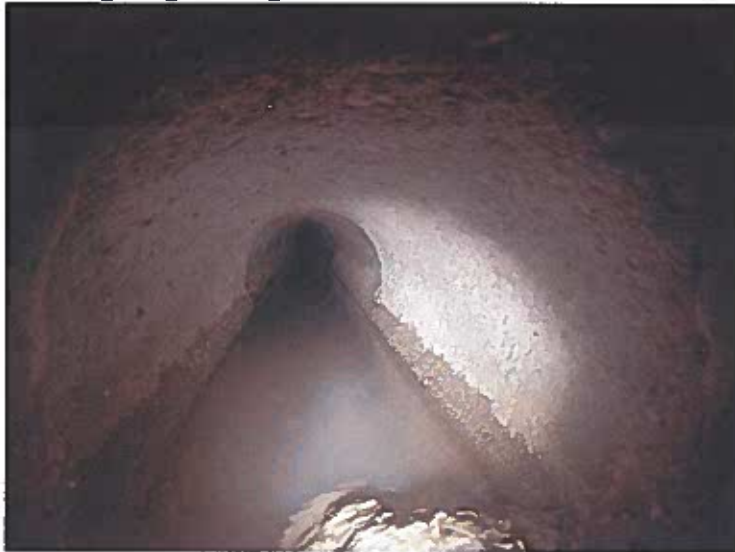
<u>Pipe</u>	<u>Clock</u>	<u>Rim To Inv</u>	<u>Direction</u>	<u>Material</u>	<u>Shape</u>	<u>Dia1</u>	<u>Dia2</u>	<u>Pipe Cond</u>	<u>Seal Cond</u>
1	6	7.98	Out	Vitrified Clay Pipe	Circular	24		Sound	Defective
<u>Special Condition</u>			Gravity Relief Connection		<u>Structure</u>		NN020516S

Comments SEAL DETERIORATED  
NN020516\_MACP\_20140201\_004.JPG

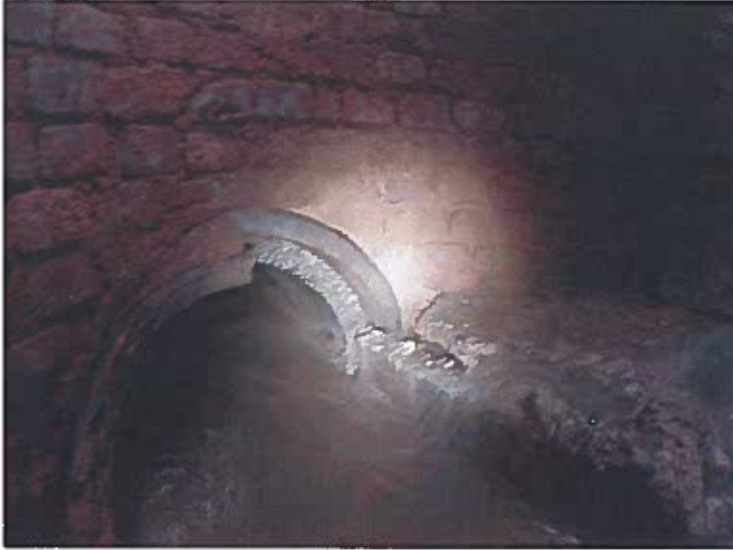
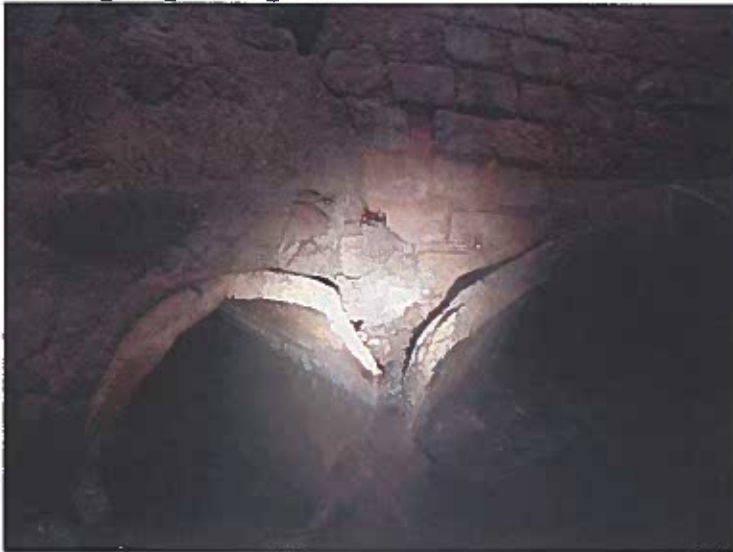
NN020516\_MACP\_20140201\_008.JPG

<u>Pipe</u>	<u>Clock</u>	<u>Rim To Inv</u>	<u>Direction</u>	<u>Material</u>	<u>Shape</u>	<u>Dia1</u>	<u>Dia2</u>	<u>Pipe Cond</u>	<u>Seal Cond</u>
4	3	7.60	In	Vitrified Clay Pipe	Circular	18		Sound	Defective
<u>Special Condition</u>		Gravity Relief Connection			<u>Structure</u>	NN020567S			
<u>Comments</u>		SEAL DETERIORATED
