**Request for Proposal
Front Street Interceptor Cleaning Addendum No. 2 to
RFP No. 400603.78.0108
February 6, 2019**

The Evaluation of The Memphis Front Street Interceptor

A Technical Memorandum

Prepared by Compliance EnviroSystems

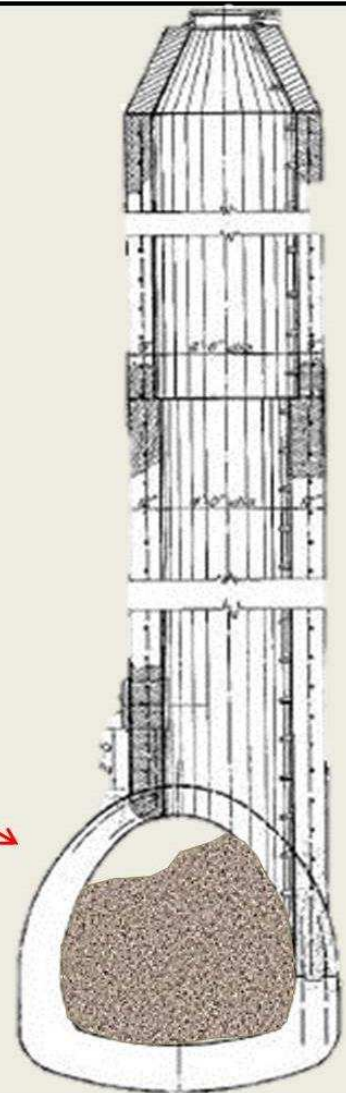
Illustration 1 – Interceptor at Peabody Place (debris field)

The Front Street Interceptor at this location has lost most of its carrying capacity. The illustration represents the shape of the debris field. The debris consist of heavy impacted solids. There is minimal flow capacity at this location.

- The atmospheric conditions within this manhole and within the interceptor presented high levels of gases that are hazardous and destructive to sanitary sewer systems.
- The interceptor at this location is near full of debris, (approximately 75%-80%) of the carrying capacity of the interceptor has been lost.
- Immediately following a heavy thunderstorm, the flow in the shaft became violent, surcharging up many feet into the manhole indicating storm water cross connections.

TASK 10: Conduct heaving cleaning operations to reclaim the lost capacity of the interceptor. These areas requiring cleaning will be located by the dive team, and utilization of sonar technologies.

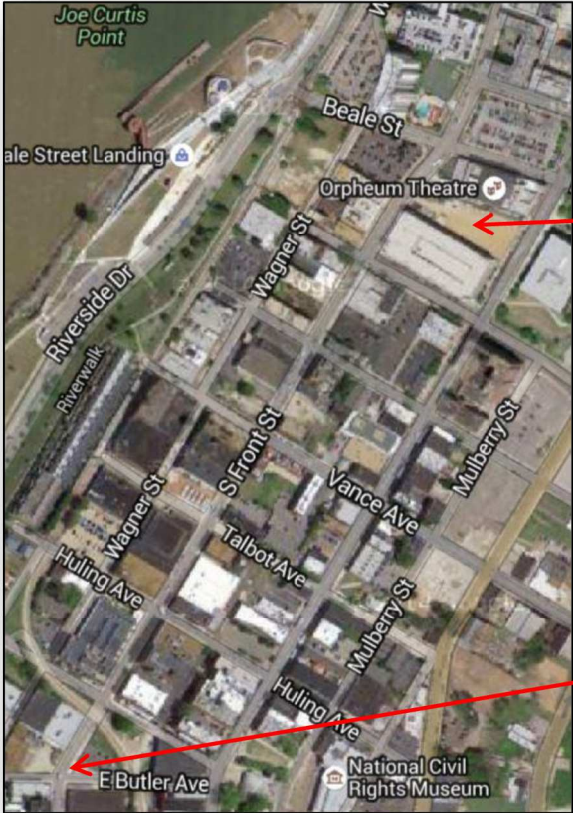
TABLE 2				
Gas Reading From Peabody Place Manhole				
H2S	O2	CO	Combust	
5	20.7	0	1.7	Surface
9	19.7	0	8.8	10 ft
20	18.7	0	XXX	20 ft
29	17.7	8	XXX	30 ft
39	17.0	4	XXX	40 ft
41	16.7	11	XXX	50 ft
47	16	15	XXX	60 ft

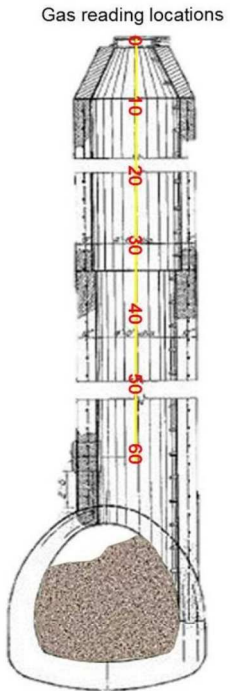
TABLE 3				
Gas Reading From Butler Ave Manhole				
H2S	O2	CO	Combust	
0	20.5	0	0	Surface
0	20.5	0	0	10 ft
0	20.4	0	0	20 ft
0	20.2	0	0	30 ft
0	20.0	0	0	40 ft
0	20.0	0	0	50 ft
0	20.0	0	0	60 ft

- The atmospheric conditions within this manhole are atypical from deep sanitary sewers. This anomaly should be further explored to determine the lack of H₂S, normal O₂ levels, and no combustible gasses.
- The interceptor at this location contains very little debris. A debris level of approximate 1 foot is present in the interceptor for several hundred feet in each direction. This anomaly should be further explored to determine the location of the debris field.
- The water temperature at this location is well below that of sanitary sewerage. This anomaly should be investigated to determine the source of this cold water.
- The visibility within the interceptor is atypical for a sanitary sewer system. This anomaly should be investigated to determine the source of this clear water.

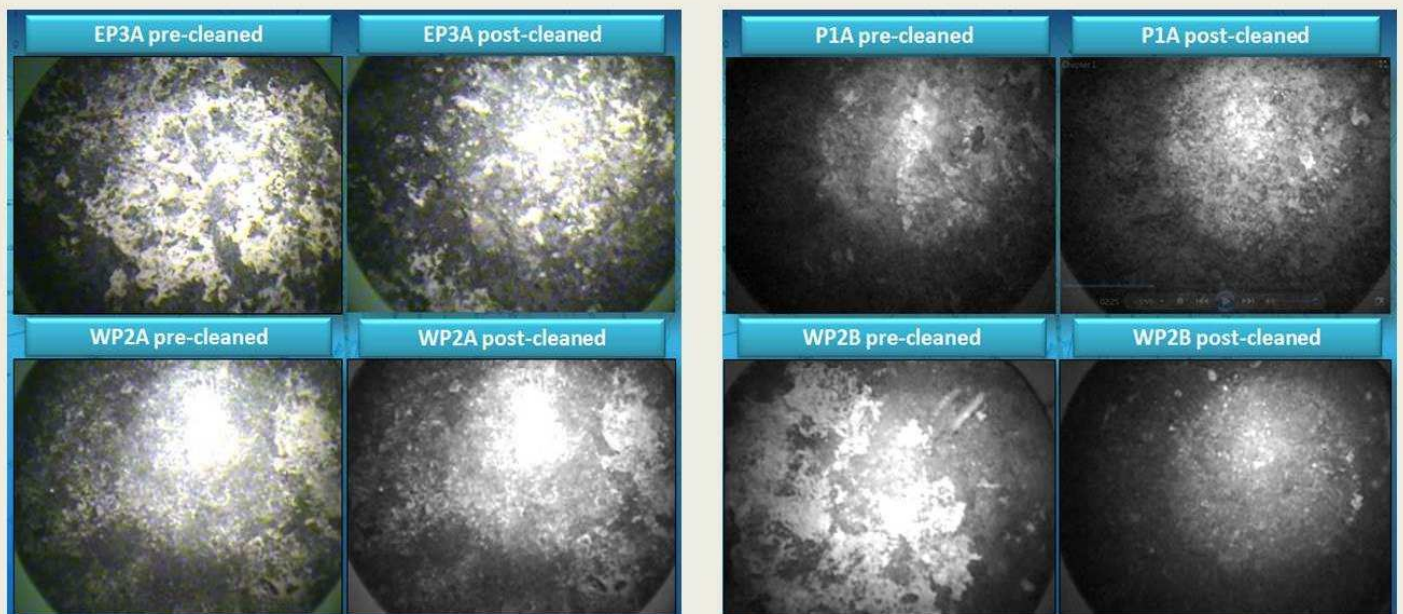
The following are Interceptor Images captured from video assessment. The interceptor at this location is in excellent structural condition. These DVDs can be observed and include diver and dive supervision audio overlays that detail each video location.

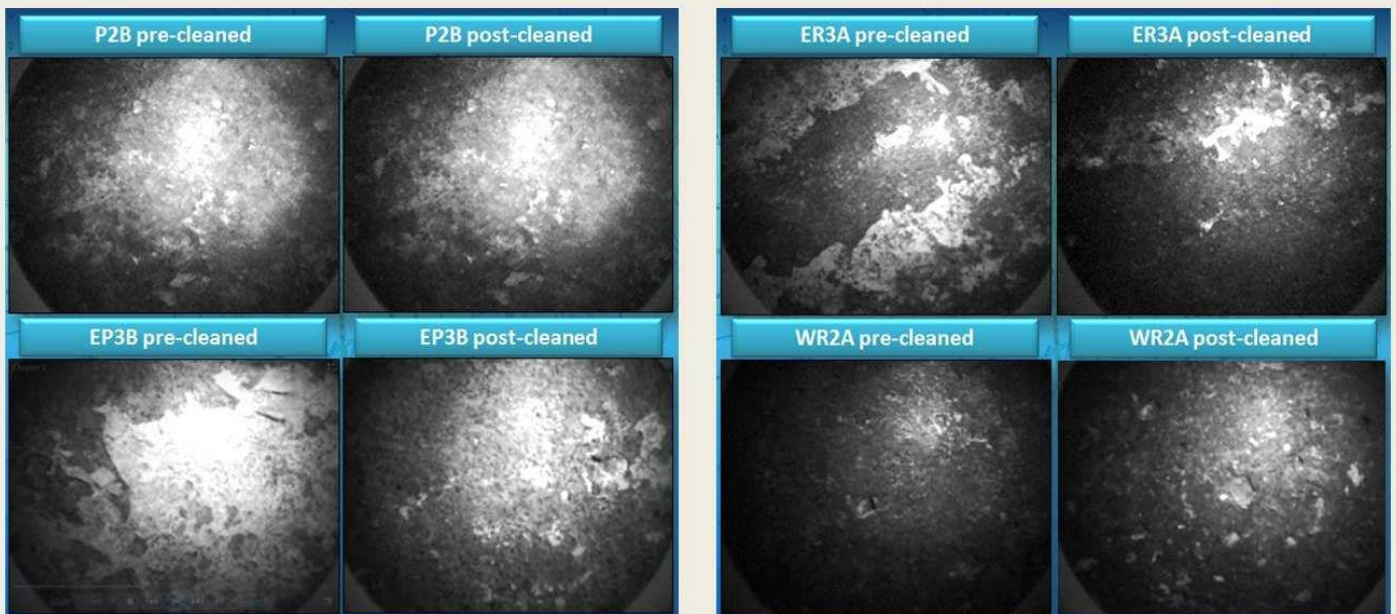
The following are Interceptor Images captured from video assessment. The interceptor at this location is in excellent structural condition. These DVDs can be observed and include diver and dive supervision audio overlays that detail each video location.

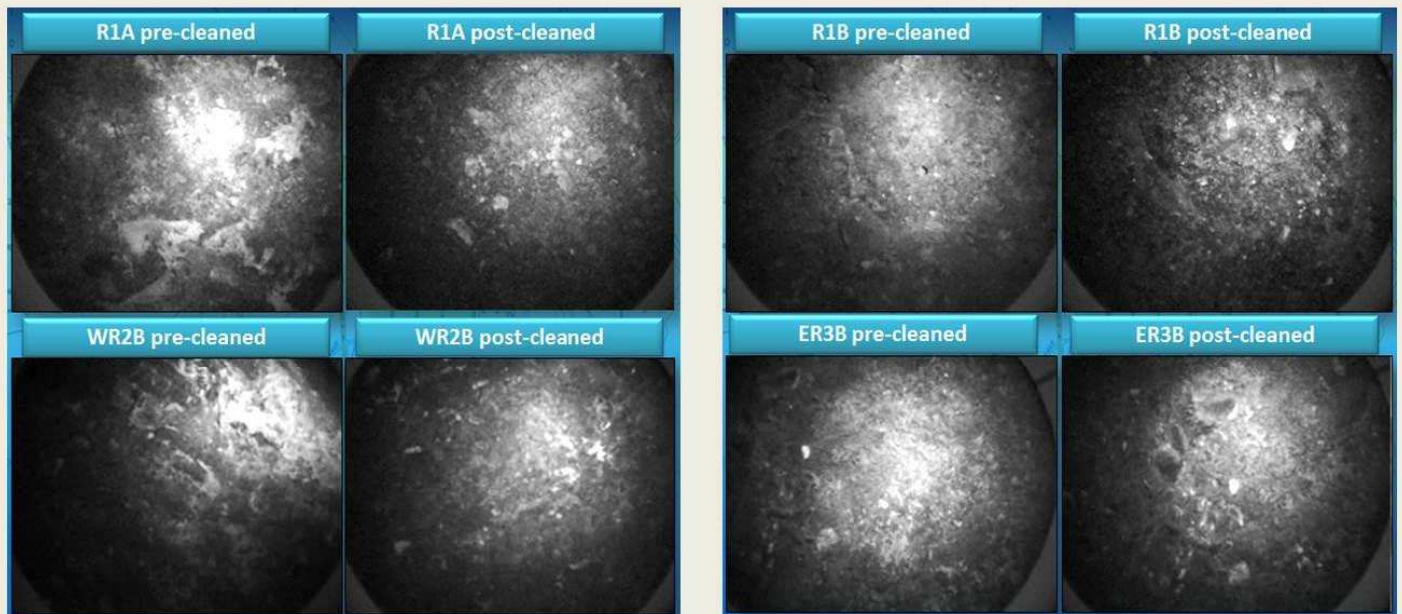
The following are Interceptor Images captured from video assessment. The interceptor at this location is in excellent structural condition. These DVDs can be observed and include diver and dive supervision audio overlays that detail each video location.

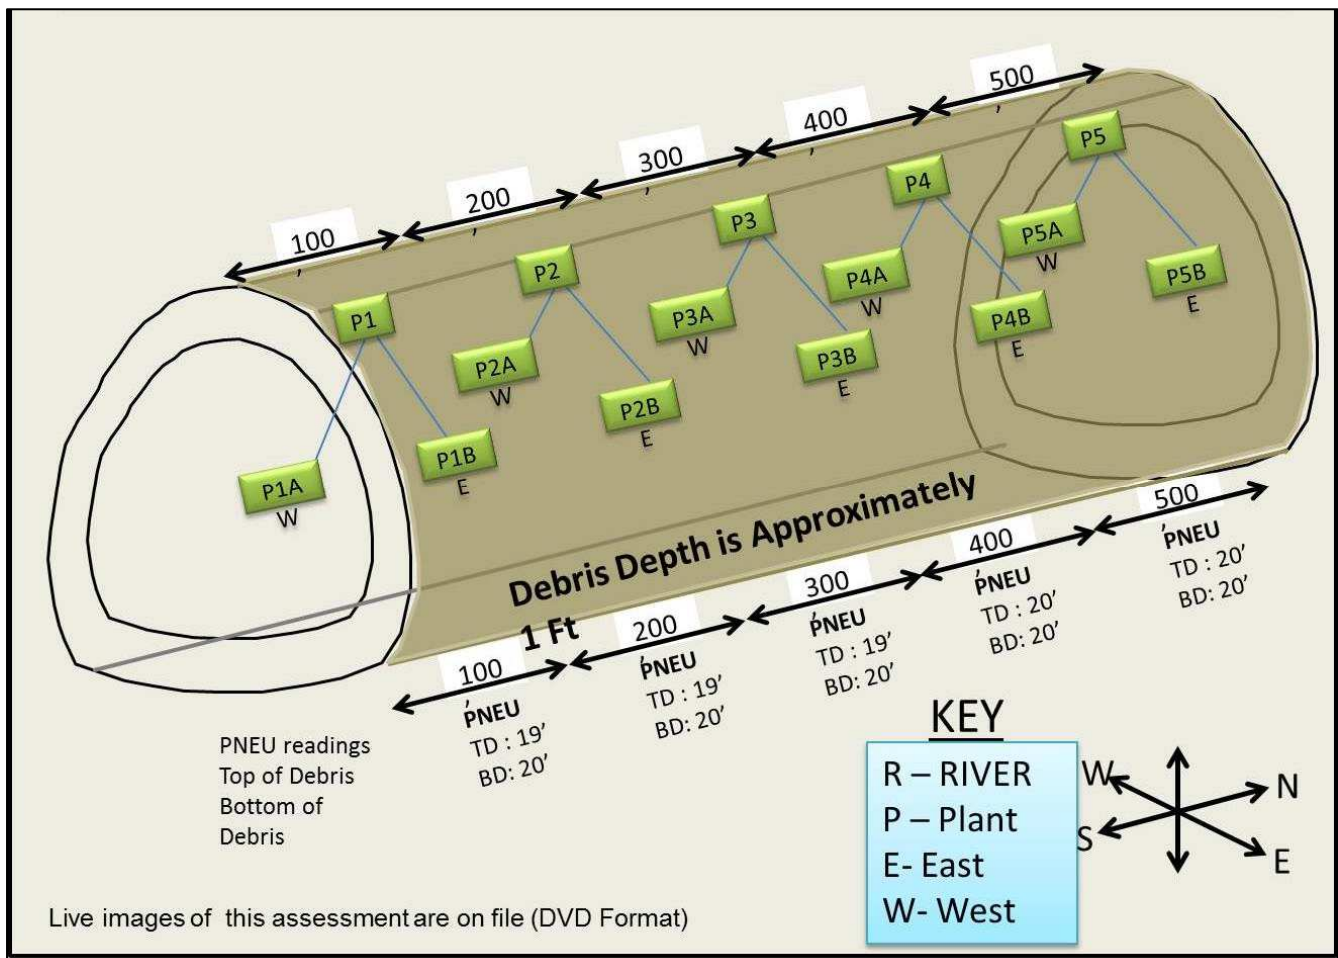
TABLE 5: Clear Box Video Locations from 500 lf Penetration Dive

Direction of dive : Towards Huling			
Position Name	Distance to Location	Clock Reference in Interceptor	Debris Depth
P1	100 lf From Centerline of Manhole	11 O'clock West Wall	Approx. 1 ft.
P1A	100 lf From Centerline of Manhole	9 O'clock West Wall	Approx. 1 ft.
P1B	100 lf From Centerline of Manhole	3 O'clock East Wall	Approx. 1 ft.
P2	200 lf From Centerline of Manhole	11 O'clock West Wall	Approx. 1 ft.
P2A	200 lf From Centerline of Manhole	9 O'clock West Wall	Approx. 1 ft.
P2B	200 lf From Centerline of Manhole	3 O'clock East Wall	Approx. 1 ft.
P3	300 lf From Centerline of Manhole	11 O'clock West Wall	Approx. 1 ft.
P3A	300 lf From Centerline of Manhole	9 O'clock West Wall	Approx. 1 ft.
P3B	300 lf From Centerline of Manhole	3 O'clock East Wall	Approx. 1 ft.
P4	400 lf From Centerline of Manhole	11 O'clock West Wall	Approx. 1 ft.
P4A	400 lf From Centerline of Manhole	9 O'clock West Wall	Approx. 1 ft.
P4B	400 lf From Centerline of Manhole	3 O'clock East Wall	Approx. 1 ft.

P5	500 lf From Centerline of Manhole	11 O'clock West Wall	Approx. 1 ft.
P5A	500 lf From Centerline of Manhole	9 O'clock West Wall	Approx. 1 ft.
P5B	500 lf From Centerline of Manhole	3 O'clock East Wall	Approx. 1 ft.

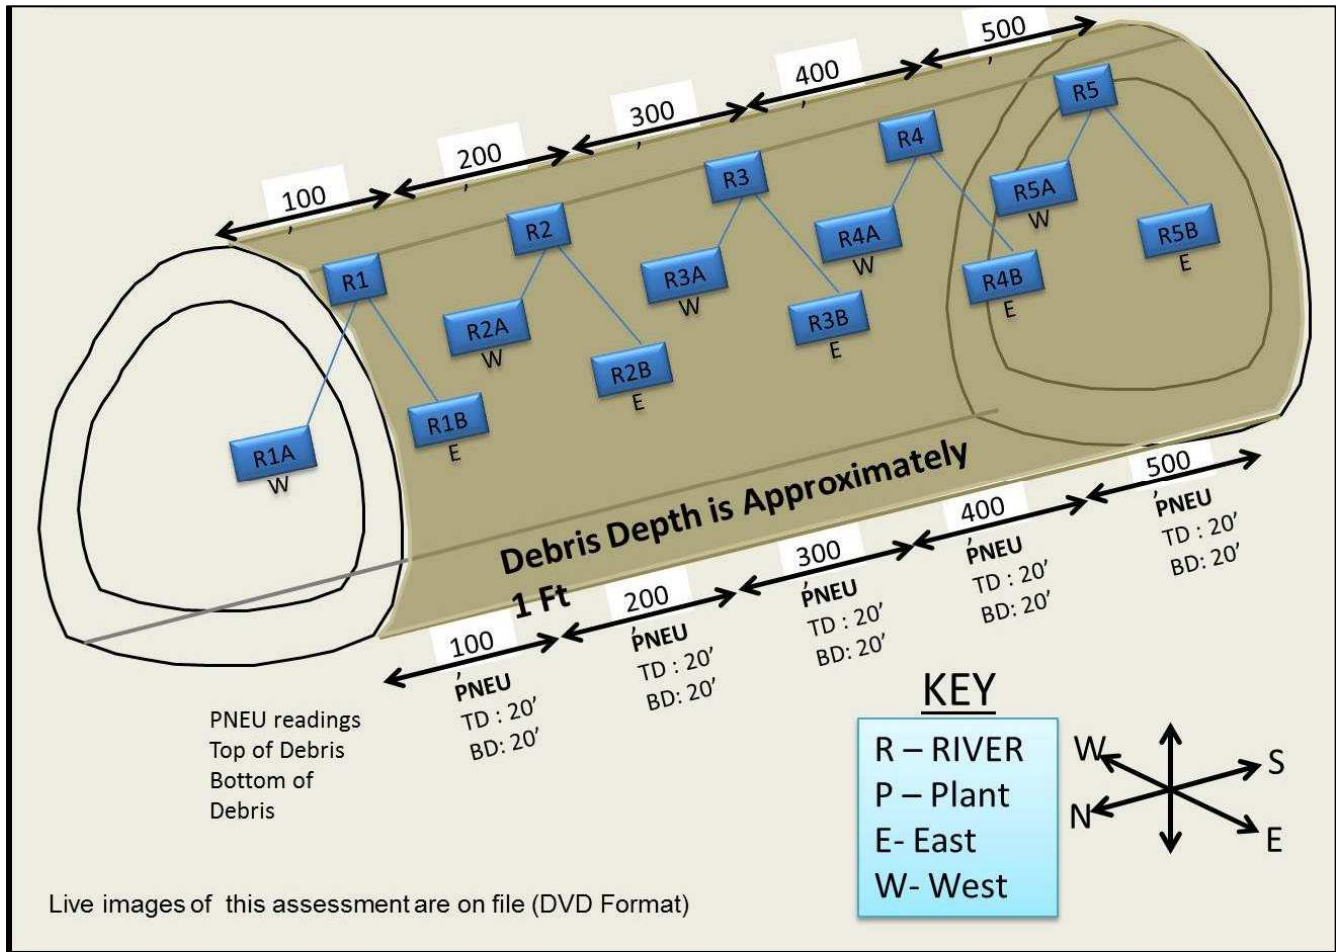
TABLE 6: Clear Box Video Locations from 500 If Penetration Dive

Direction of dive : Towards Calhoun St			
Position Name	Distance to Location	Clock Reference in Intercepto	Debris Depth
R1	100 lf From Centerline of Manhole	11 O'clock West Wall	<= 1 ft.
R1A	100 lf From Centerline of Manhole	9 O'clock West Wall	<= 1 ft.
R1B	100 lf From Centerline of Manhole	3 O'clock East Wall	<= 1 ft.
R2	200 lf From Centerline of Manhole	11 O'clock West Wall	<= 1 ft.
R2A	200 lf From Centerline of Manhole	9 O'clock West Wall	<= 1 ft.
R2B	200 lf From Centerline of Manhole	3 O'clock East Wall	<= 1 ft.
R3	300 lf From Centerline of Manhole	11 O'clock West Wall	<= 1 ft.
R3A	300 lf From Centerline of Manhole	9 O'clock West Wall	<= 1 ft.
R3B	300 lf From Centerline of Manhole	3 O'clock East Wall	<= 1 ft.
R4	400 lf From Centerline of Manhole	11 O'clock West Wall	<= 1 ft.
R4A	400 lf From Centerline of Manhole	9 O'clock West Wall	<= 1 ft.
R4B	400 lf From Centerline of Manhole	3 O'clock East Wall	<= 1 ft.

R5	500 lf From Centerline of Manhole	11 O'clock West Wall	<= 1 ft.
R5A	500 lf From Centerline of Manhole	9 O'clock West Wall	<= 1 ft.
R5B	500 lf From Centerline of Manhole	3 O'clock East Wall	<= 1 ft.

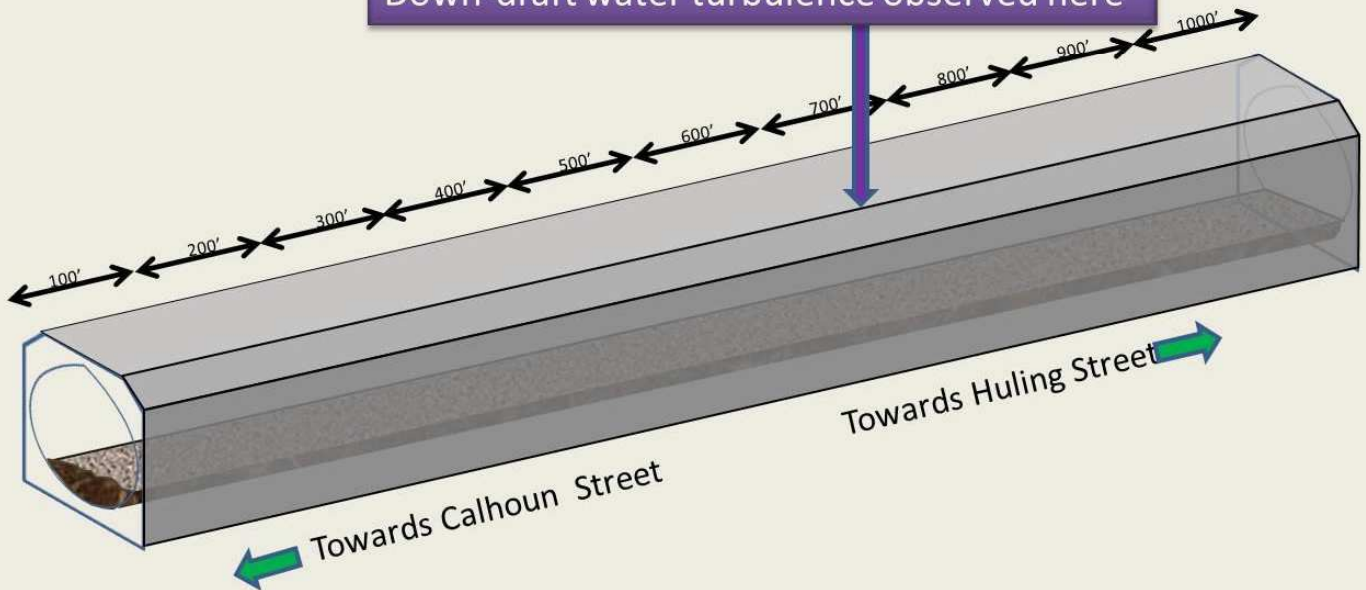
ILLUSTRATION 2: Schematic of 1000 linear ft. penetration dive with diver observations

Tactile observations by diver during this penetration dive:

- The structural condition of the interceptor is “excellent”
- Visibility within the interceptor is very good to excellent
- Water temperatures are very cold for sanitary sewerage
- A water sample was taken within the interceptor
- Debris level was around 1 foot deep throughout the inspection
- Some material was observed leaching at some joints

Down-draft water turbulence observed here
