City of Memphis

Final Priority Areas Project Report

August 13, 2023

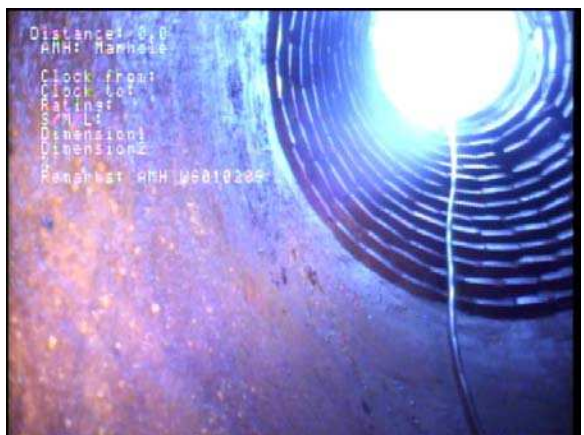
AMH AMH WS010209 01.f.

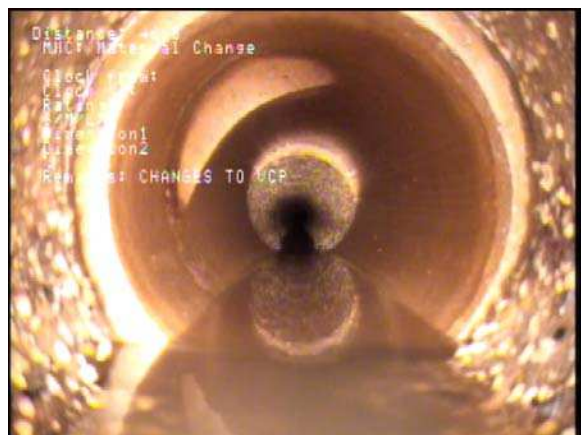
MMC Material Change -- CHANGES TO VCP 46.81.f.

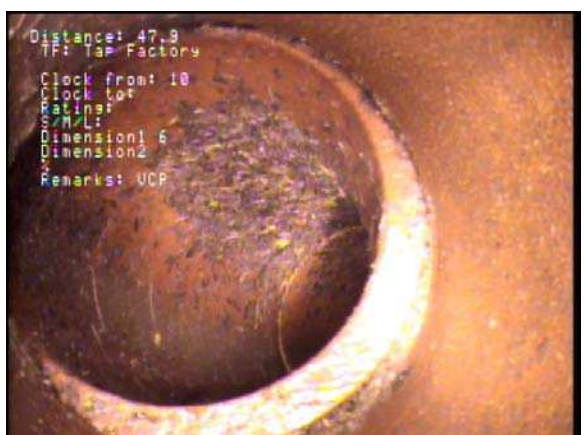
TF Tap Factory -- VCP 47.91.f.

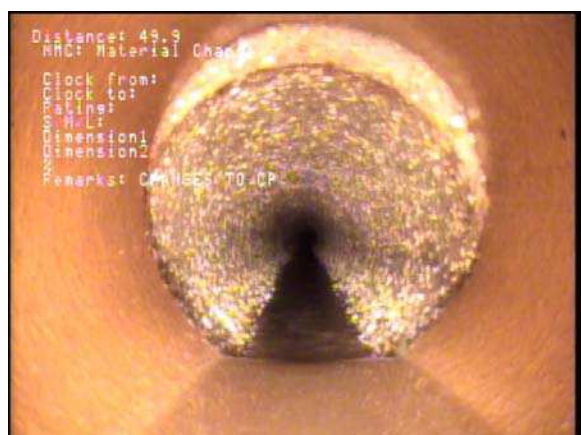
MMC Material Change -- CHANGES TO CP 49.91.f.

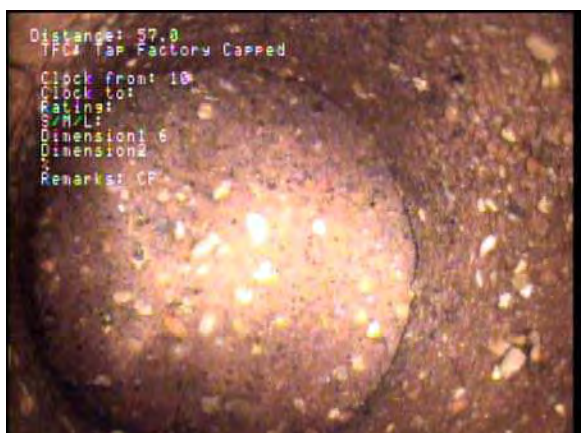
TFC Tap Factory Capped -- CP 571.f.

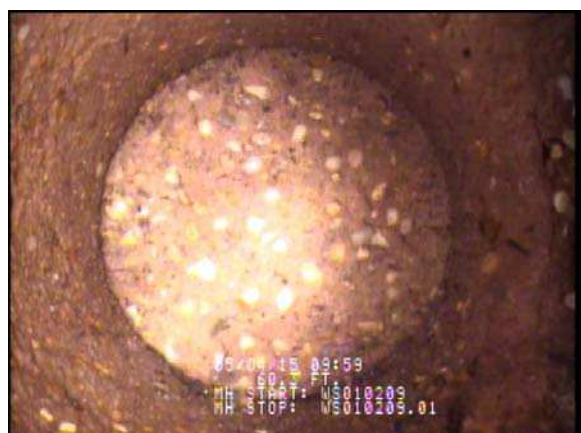
TFC Tap Factory Capped -- CP 60.21.f.

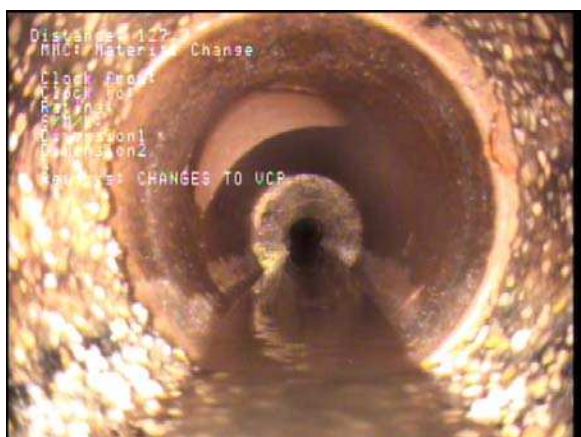
MMC Material Change -- CHANGES TO VCP 127.7 l.f.

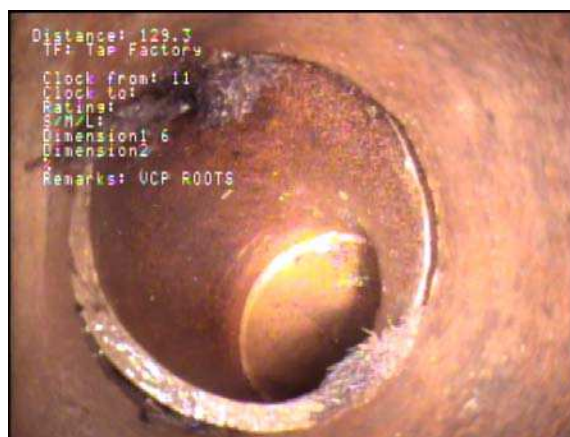
TF Tap Factory -- VCP -- ROOTS 129.3 l.f.

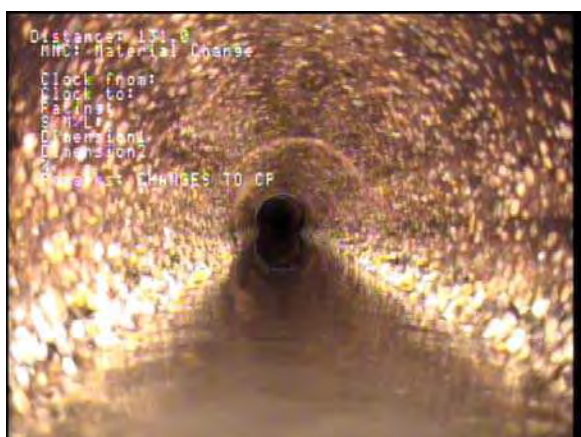
MMC Material Change -- CHANGES TO CP 131 l.f.

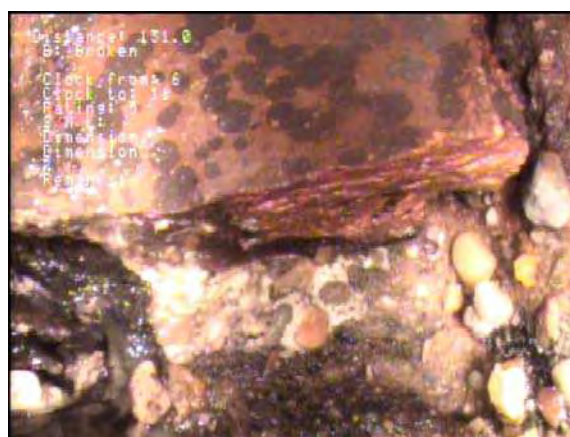
B Broken 131 l.f.

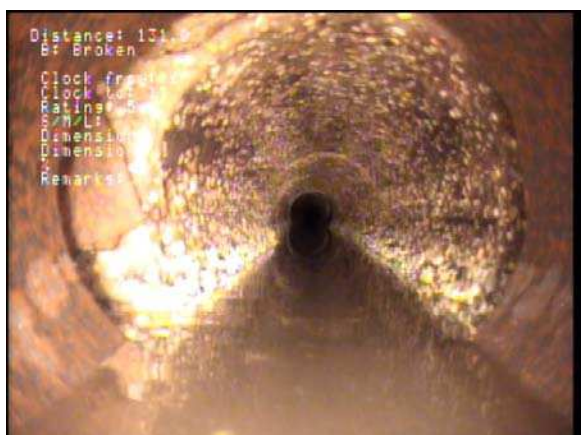
B Broken 131 l.f.

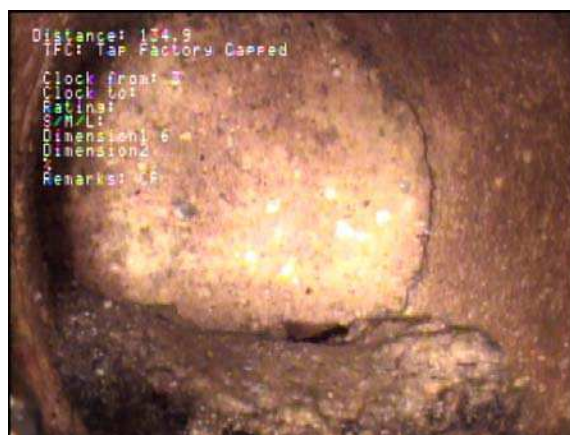
TFC Tap Factory Capped -- CP 134.9 l.f.

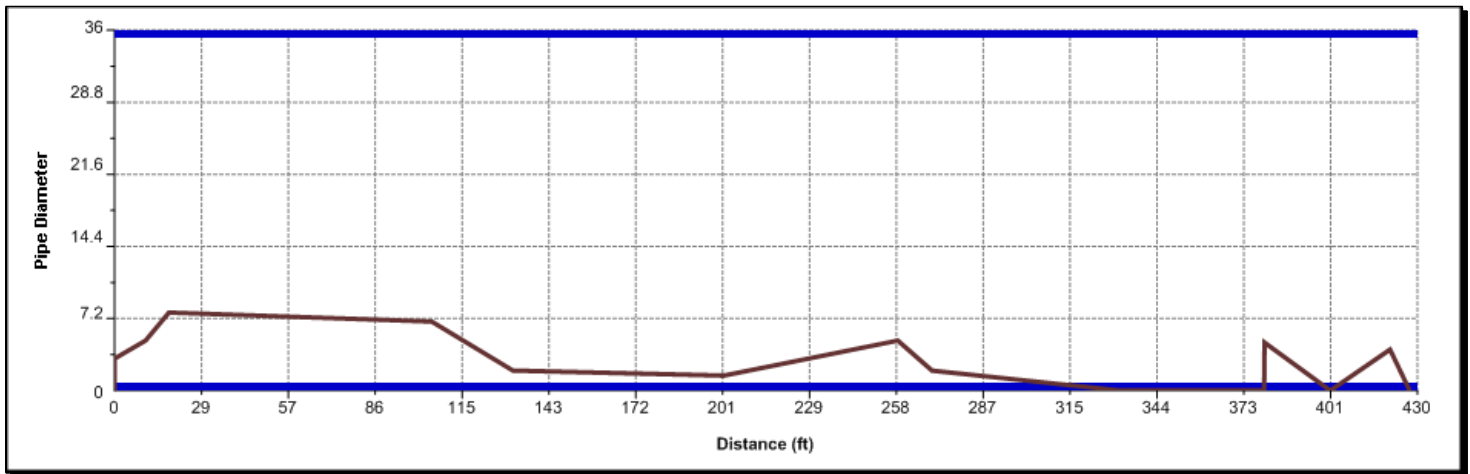
SEDIMENT IN PIPE

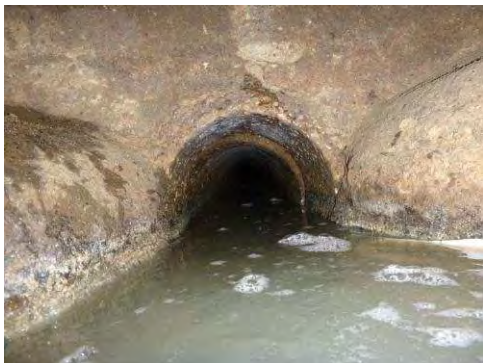
Pipe #:	1	Clock:	6	Rim to Invert:	10.1
Direction:	Out	Material:	Concrete Pipe (non-reinf)		
Shape:	Circular	Dia 1:	8	Dia 2	0
Pipe Condition:	Defective	Seal Condition:	Sound		
Special Condition:	Gravity Relief Connection		Pipe ID:	NN022450	
Comments:
