Manhole Inspection Header Form  
Level 1 & 2 Inspections

**Manhole Number** NN020517

**Purpose** Sewer System Evaluation Survey

**PO Number**  
**Date** 02/01/2014      **Time** 7:49 am  
**Street** LAPALOMA AND PARKWAY      **City** Memphis  
**Location** CENTER STREET  
**Manhole Number** NN020516      **Rim to Invert** 7.92      **Grade to Invert** 7.92      **Rim to Grade** 0.00

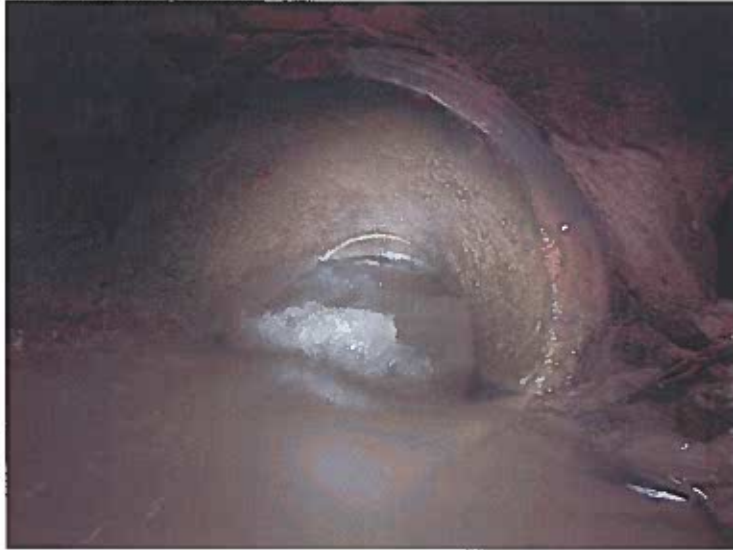
NN020517\_MACP\_20140131\_004.JPG

Pipe	Clock	Rim To Inv	Direction	Material	Shape	Dia1	Dia2	Pipe Cond	Seal Cond
1	6	7.46	Out	Vitrified Clay Pipe	Circular	24		Sound	Sound
<u>Special Condition</u>			Gravity Relief Connection		<u>Structure</u>		NN020517S

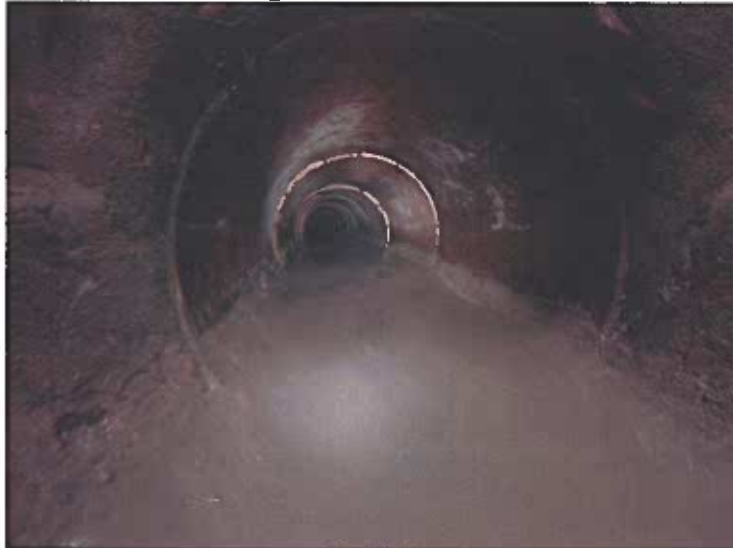
NN020517\_MACP\_20140131\_006.JPG

Pipe	Clock	Rim To Inv	Direction	Material	Shape	Dia1	Dia2	Pipe Cond	Seal Cond
3	10	7.48	In	Vitrified Clay Pipe	Circular	24		Sound	Sound
<u>Special Condition</u>			Gravity Relief Connection		<u>Structure</u>		NN020518S

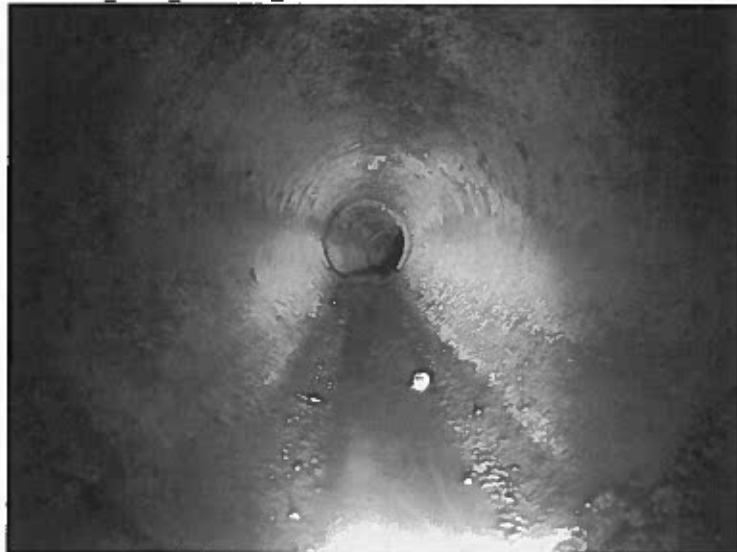
NN020517\_MACP\_20140131\_007.JPG

<u>Pipe</u>	<u>Clock</u>	<u>Rim To Inv</u>	<u>Direction</u>	<u>Material</u>	<u>Shape</u>	<u>Dia1</u>	<u>Dia2</u>	<u>Pipe Cond</u>	<u>Seal Cond</u>
4	12	6.41	In	Vitrified Clay Pipe	Circular	8		Sound	Sound
<u>Special Condition</u>		Lateral to Building			<u>Structure</u>	SVC

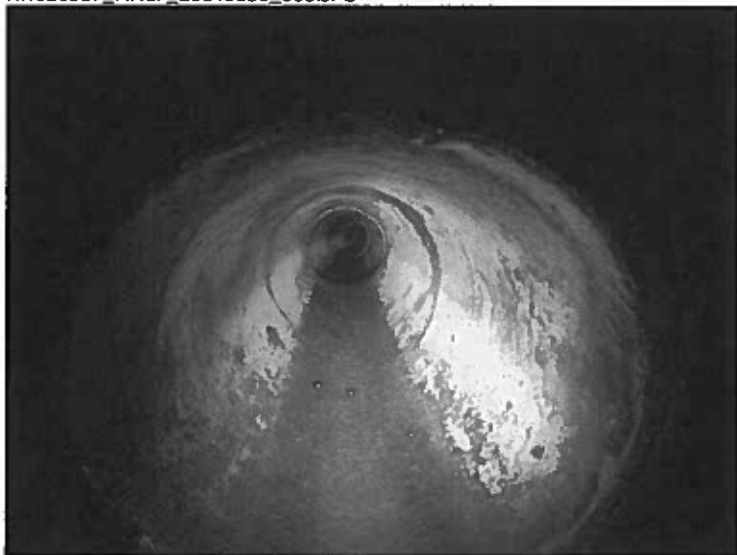
NN020517\_MACP\_20140131\_008.JPG

<u>Pipe</u>	<u>Clock</u>	<u>Rim To Inv</u>	<u>Direction</u>	<u>Material</u>	<u>Shape</u>	<u>Dia1</u>	<u>Dia2</u>	<u>Pipe Cond</u>	<u>Seal Cond</u>
5	3	6.50	In	Vitrified Clay Pipe	Circular	8		Sound	Sound
<u>Special Condition</u>		Gravity Relief Connection			<u>Structure</u>	SVC

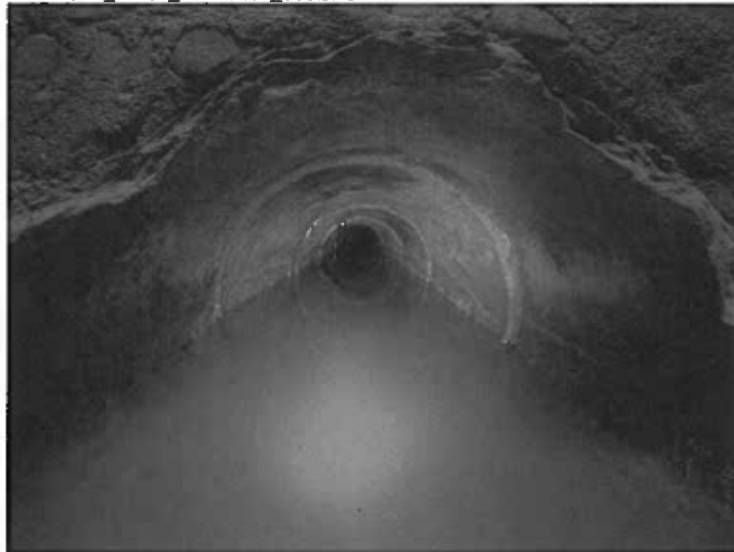
NN020516\_MACP\_20140201\_006.JPG

<u>Pipe</u>	<u>Clock</u>	<u>Rim To Inv</u>	<u>Direction</u>	<u>Material</u>	<u>Shape</u>	<u>Dia1</u>	<u>Dia2</u>	<u>Pipe Cond</u>	<u>Seal Cond</u>
2	9	6.32	In	Concrete Pipe (non-reinforced)	Circular	8		Sound	Sound
<u>Special Condition</u>		Gravity Relief Connection			<u>Structure</u>	NN020607S

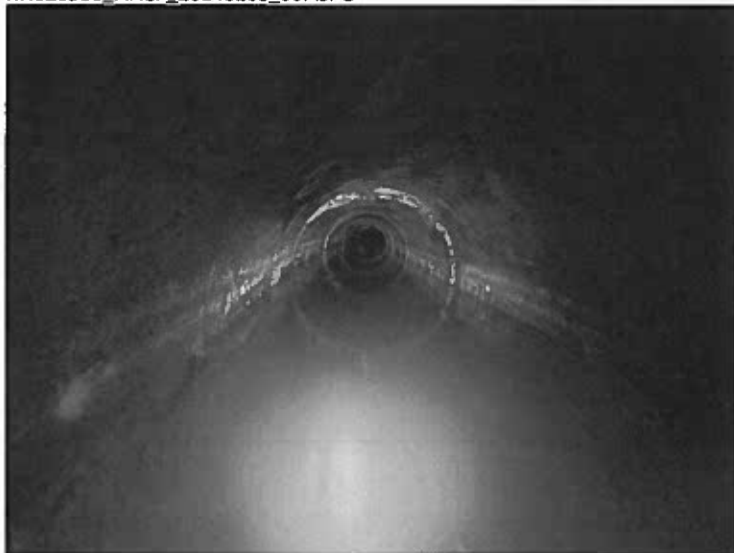
NN020516\_MACP\_20140201\_007.JPG

<u>Pipe</u>	<u>Clock</u>	<u>Rim To Inv</u>	<u>Direction</u>	<u>Material</u>	<u>Shape</u>	<u>Dia1</u>	<u>Dia2</u>	<u>Pipe Cond</u>	<u>Seal Cond</u>
3	12	7.92	In	Vitrified Clay Pipe	Circular	24		Sound	Sound
<u>Special Condition</u>		Gravity Relief Connection			<u>Structure</u>	NN020516.01S
