**Request for Proposal
Front Street Interceptor Cleaning Addendum No. 2 to
RFP No. 400603.78.0108
February 6, 2019**

The Evaluation of The Memphis Front Street Interceptor

A Technical Memorandum

Prepared by Compliance EnviroSystems

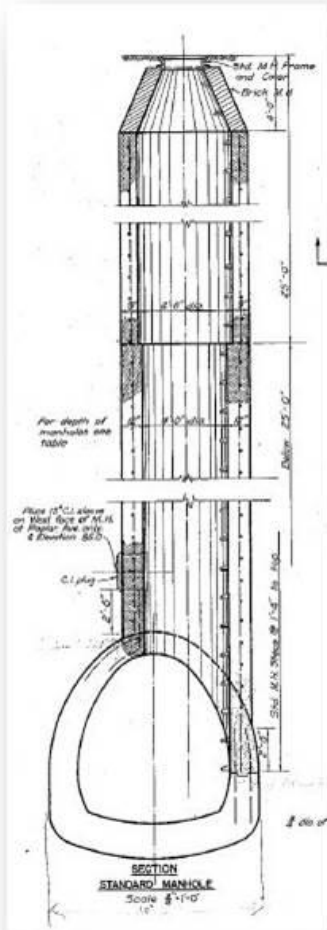
Type 1- Standard MH

Type 1- This is a typical manhole. There are brick with fixed pre-cast steps that lead into the interceptor. These are the manholes that the Specialty Dive Team will enter.

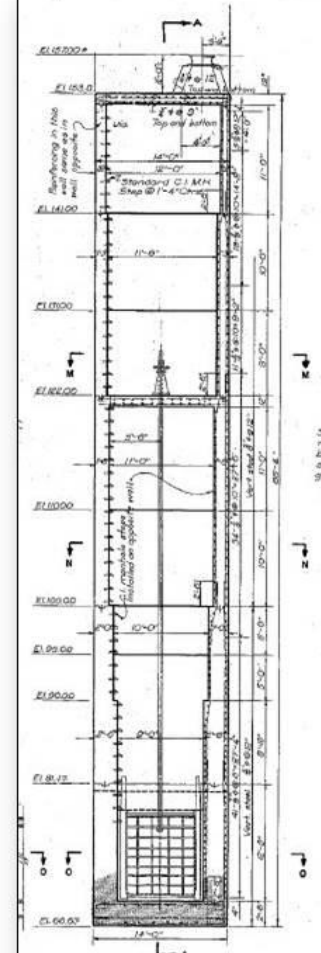
Type 3- Sluice Gate MH

Type 3 – This unique manhole has multiple chambers and a sluice gate with a control wheel for opening and shutting. The sluice gate has been closed since around 1975.

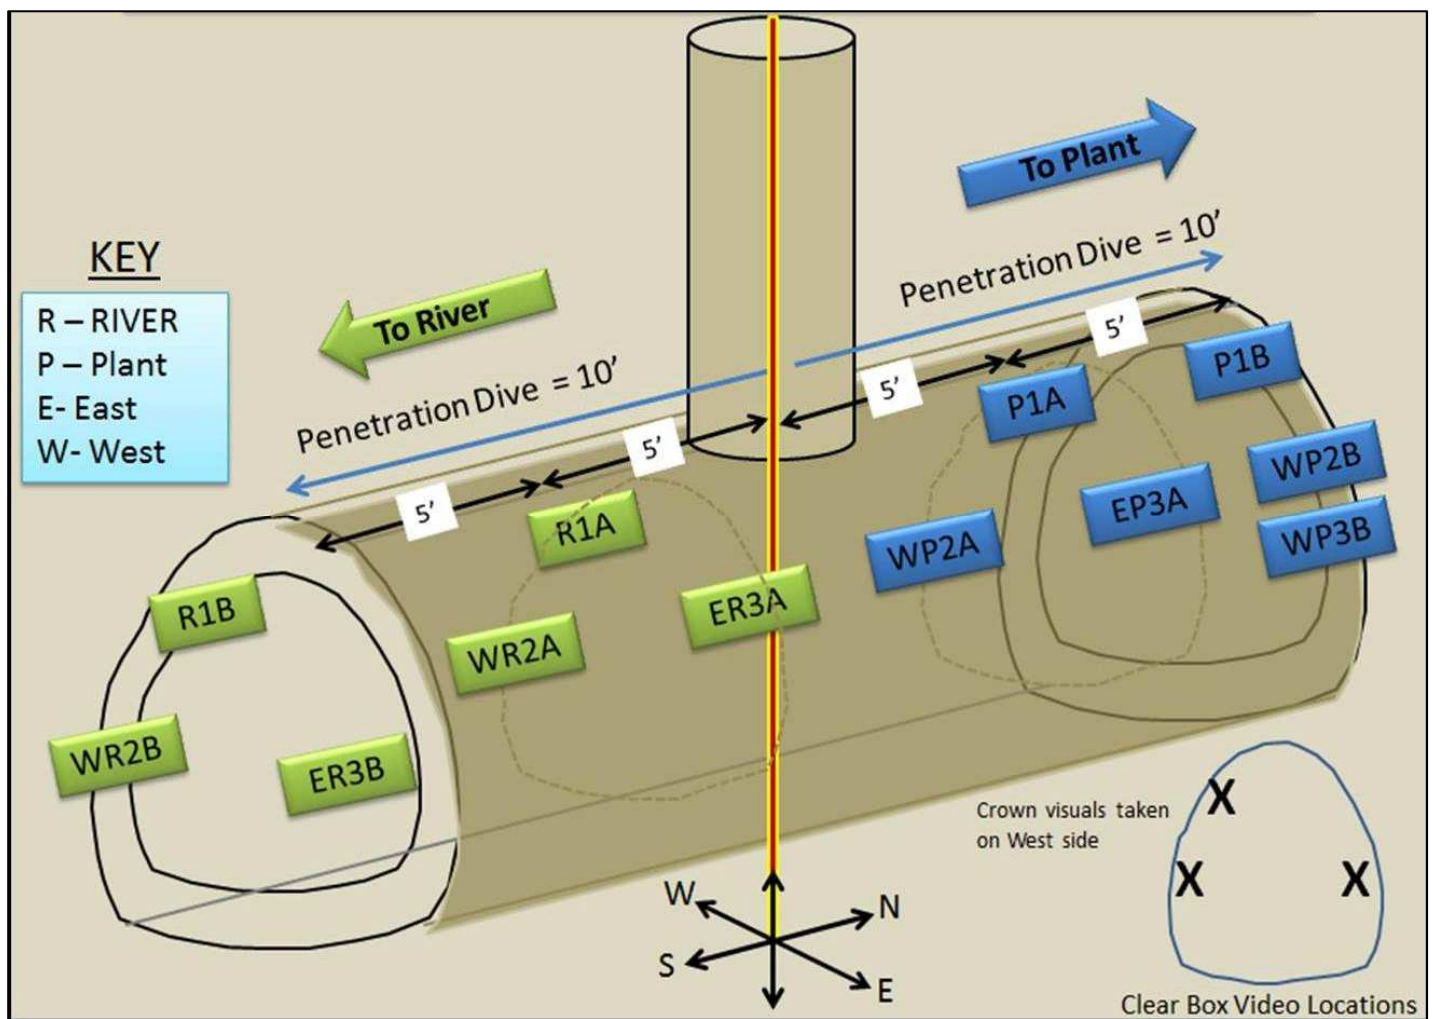
TABLE 4: Clear Box Video Locations from 10 If Penetration Dive

The following are Interceptor Images captured from video assessment. The interceptor at this location is in excellent structural condition. These DVDs can be observed and include diver and dive supervision audio overlays that detail each video location.

- The structural condition of the interceptor is “excellent”
- Visibility within the interceptor is very good to excellent
- Water temperatures are very cold for sanitary sewerage
- A water sample was taken within the interceptor
- Debris level was around 1 foot deep throughout the inspection
- Some material was observed leaching at some joints
